Riverside Recreation Ground

River Improvement Plan

**WATFORD
BOROUGH
COUNCIL**

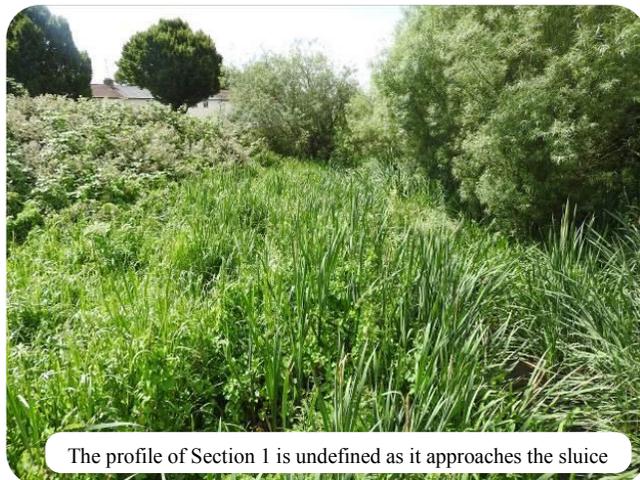
As section 1 progresses further towards the sluice gate it becomes increasingly deep and slow flowing, with thick layers of silt accumulating upstream of the structure. This channel is choked with emergent vegetation and has a very undefined profile. The sluice gate retains a significant head of water and is currently not operational. This has resulted in the loss in ability to control flows downstream of the structure and comparatively high water levels upstream of the structure. A relatively small amount of flow is able to pass through the undershot sluice and as a result of this the channel downstream is drying out, with very low water levels and abundant vegetation growing across the full width of the riverbed. The section of the channel immediately below the sluice has brick banks and is exposed to a high degree of human pressure due to the presence of residential properties and a mechanics yard in the riparian zone. As the channel progresses towards

The profile of Section 1 is undefined as it approaches the sluice

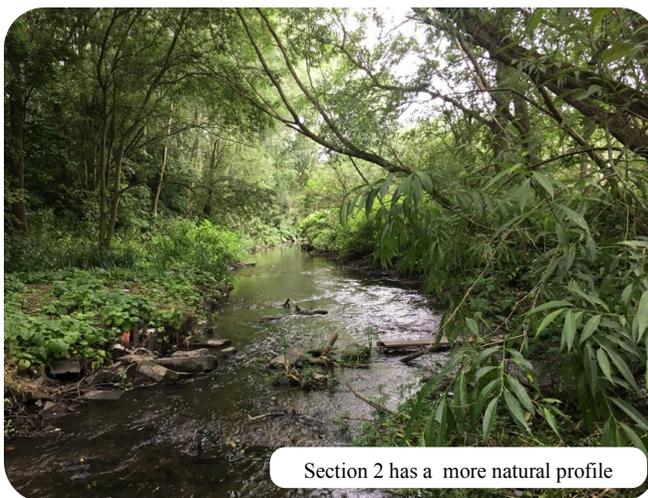
Section 2 has a more natural profile

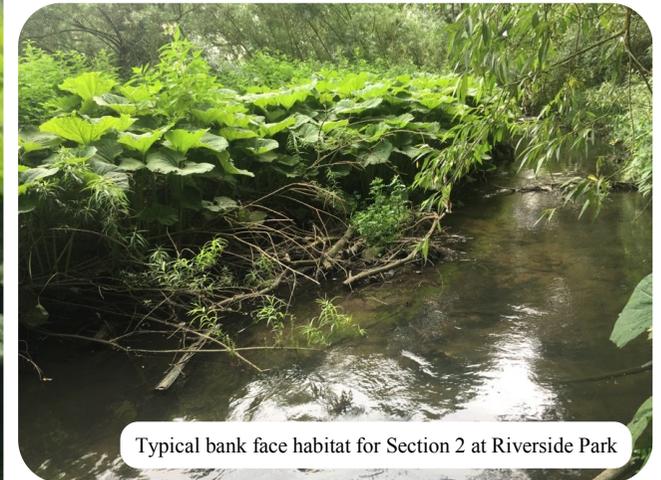
Typical bank face habitat for Section 2 at Riverside Park

Section 2 offers distinctively better bank face habitat than section 1 and offers good potential water vole habitat. The profile of the channel is less modified and low-lying banks with a gentle gradient are present between the start of the channel to the location where the former railway line crosses the river. The Northern bank face is populated with occasional crack willow, interspersed with large areas of

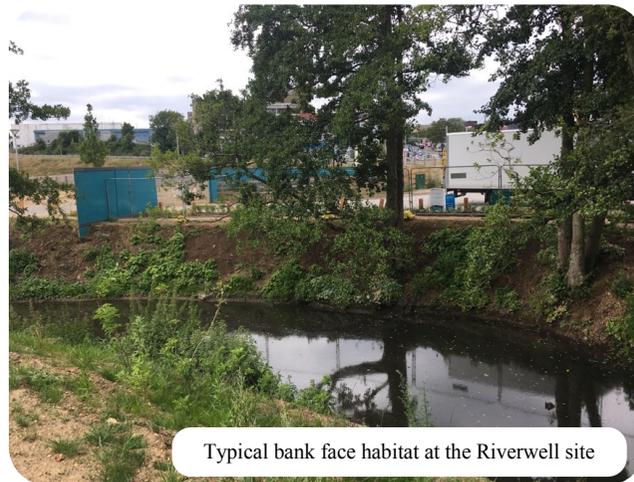
Downstream of the railway bridge at the Riverwell site, the banks of the river are in less favourable condition and currently do not provide suitable habitat for water voles. The channel appears to have been recently reprofiled with the northern bank of the river being of an especially steep gradient. The steep profile of the bank is not beneficial for aquatic plant species as it will be free draining and dry. The combination of the steep nature of the bank and lack of vegetation may leave it open to erosion and prone to collapse during high flow events. The Northern Bank is currently dominated by tall herbs, such as stinging nettles and has occasional overhanging tree cover. The southern bank is less steep but still has a considerable gradient. It is clear that much of the bank is comprised of 'new' materials that have been deposited on the bank face during the construction of the Riverwell site. Much of the bank face is now comprised of gravels and loose earth which is too free draining and dry for most aquatic plant species. The bank is currently vegetated with tall herbs and grasses, short creeping herbs and occasional cover

from the odd willow, but also provides large areas of exposed bare earth. Like the northern bank, this area is also likely to be prone to erosion.

Typical bank face habitat at the Riverwell site

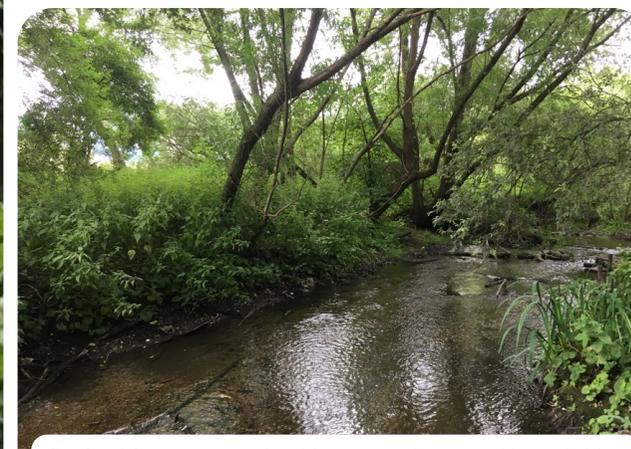
Section 2 is more energetic with coarser substrate and better habitat

Section 2 is a more dynamic and energetic reach of river than section 1. It begins as a fast flowing, shallow (0.2m) channel, with riffle features and rippled flow before becoming a deeper and smoother flowing watercourse as it progresses westwards. The riverbed is comprised of a range of substrate types including cobble, gravel pebble and silt, but for the most part is dominated by sand and fine gravels. This provides much better fish spawning habitat than section 1, although the abundance of more coarse substrate types would be preferential. Areas of loose silt are also present in the margins of the river and become more extensive as the river flows towards the Riverwell site downstream.

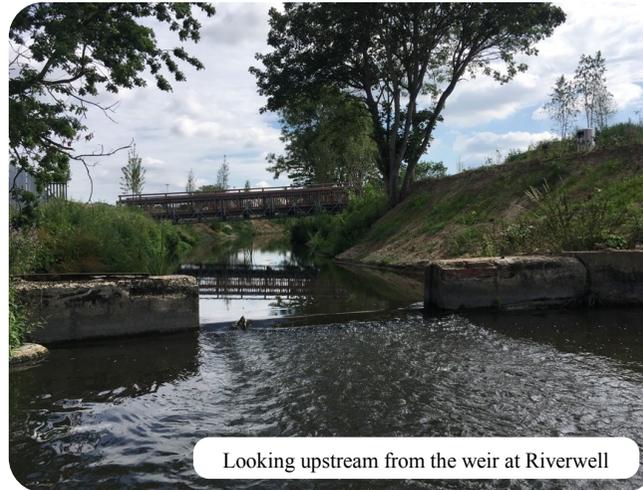
At the Riverwell site, downstream of Riverside Park, the bed of the river appears to have been dredged. The more variable, coarser substrate found upstream is no longer present and the riverbed rapidly turns to loose silt. Occasional areas of gravel are present in the margins of the river, illustrating the former bed level in this location. The alteration of the riverbed has resulted in the river's natural gradient being lost and a change in the hydrology of the watercourse. This is further influenced by presence of a weir, at the tail end of the site, which impounds flows and increases siltation. Levels of fine sediment are also high in this location as the rivers banks are exposed to erosion (high gradient and loose substrate). No submerged vegetation was present at the time of survey, but emergent plants had been introduced to the margins of the river by local volunteers led by Community Connections Projects CIC.

Looking upstream from the weir at Riverwell

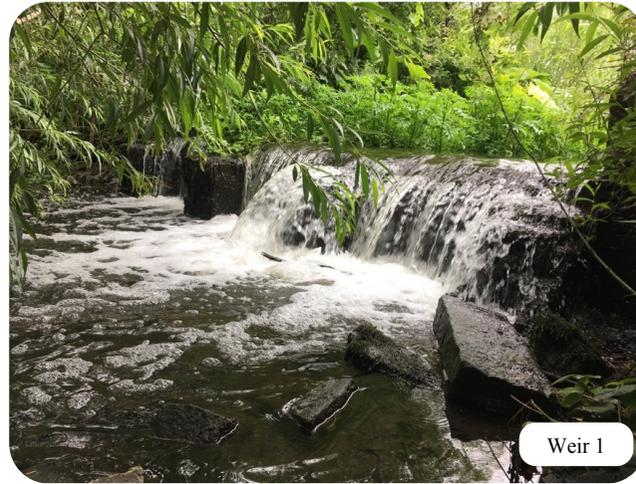
Weir 1 controls flows from section 1 to section 2. The structure is comprised of historic masonry and retains a head of water of around 0.5 meters. Remnants of a more extensive structure suggest that sluice gates also used to be present on the crest of the weir. This would have allowed the mill operators greater control over the flow split between the two channels than exists today.

The structure is likely to pose as a barrier to fish passage, due to its vertical nature and height. It is recommended that a non-technical fish passage solution is identified due to the strategic importance of this location. Fish passage upstream from this point is unimpeded for a number of kilometres and rectifying this barrier would ensure the Watford Colne is reconnected with the wider catchment once more. Removing barriers to fish migration will make the Colne's fish stocks more resilient and will eventually negate the requirement for additional fish stockings in Watford, so long as water quality is improved. Potential solutions to make the barrier passable for coarse fish could involve notching the structure, creating a bypass channel, installing a rock ramp or installing a pre barrage to reduce the hydraulic head of the weir.

Pre-barrages are created via installing a series of notched walls downstream of a weir in order to back up water over the weir crest. This reduces the hydraulic head of the structure and increases the water depth over a structure by breaking it into small sections that can be traversed individually. Each section also provides a resting location to give fish time to recover when fighting fast flowing water. This type of pass would be most appropriate for weir 1.

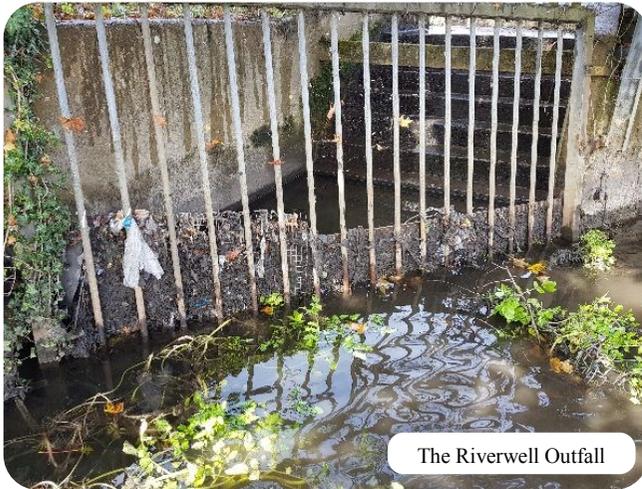
The Riverwell Outfall

The outfall at the Riverwell site is served by an oil and grit separator which is not suitable for treating heavily polluted water. Since the creation of this facility half a century ago, the surface water catchment it serves has grown significantly and the number of interactions with the foul water system has grown significantly too. This has reduced the effectiveness of the oil and grit interceptor as it was not initially designed to treat the volume of water

passing through the system, nor was it designed to treat raw sewage. Thames Water and Kier Homes (Riverwell developer) have met with the Rediscovering The River Colne project team in order to set out a way of replacing the facility. A range of options are currently being discussed to prevent domestic sewage reaching the facility in the first place and to replace the facility itself to ensure polluted surface water can be more efficiently treated.

6. The outdated surface water asset at the Riverwell site should be replaced with a solution that prevents regular pollution incidents from occurring.
7. If restoring flow to Section 1 is desired, a consultant should be engaged to model the

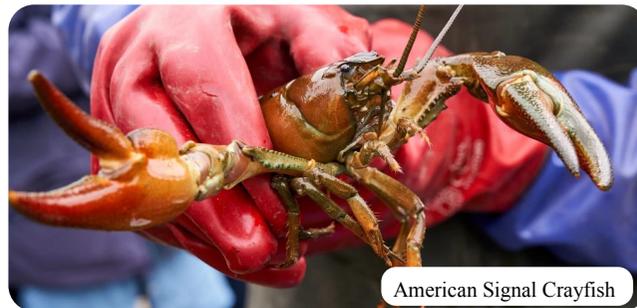
American Signal Crayfish

American signal crayfish burrows were found within the small area of earth bank to the north west of the site. The species is common place in the Colne Catchment. Crayfish Burrowing mobilises sediment which has a negative impact on both water quality and habitat. If deemed a priority, the species should be monitored via the Rediscovering the River Colne Environmental Monitoring Project.

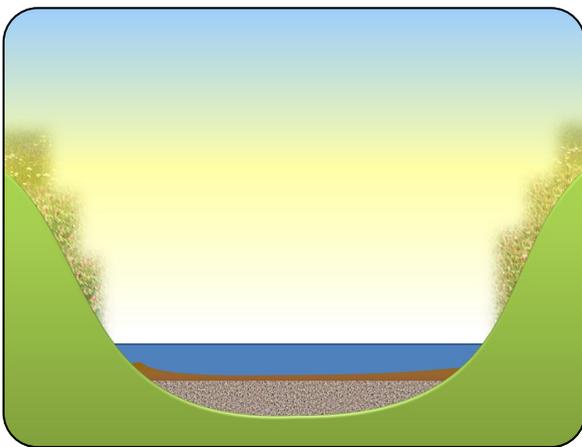
The river channel has a modified profile and uniform depth. Siltation occurs in over shaded areas where emergent plant species are not present to stabilise loose silt in the margins of the river.

Over shading trees can be coppiced and repurposed to create brush berms and flow deflectors within the channel to mimic natural sinuosity, stabilise sediment and to create a variety of depths and flow types.
