Oxhey Park

River Improvement Plan

**WATFORD
BOROUGH
COUNCIL**

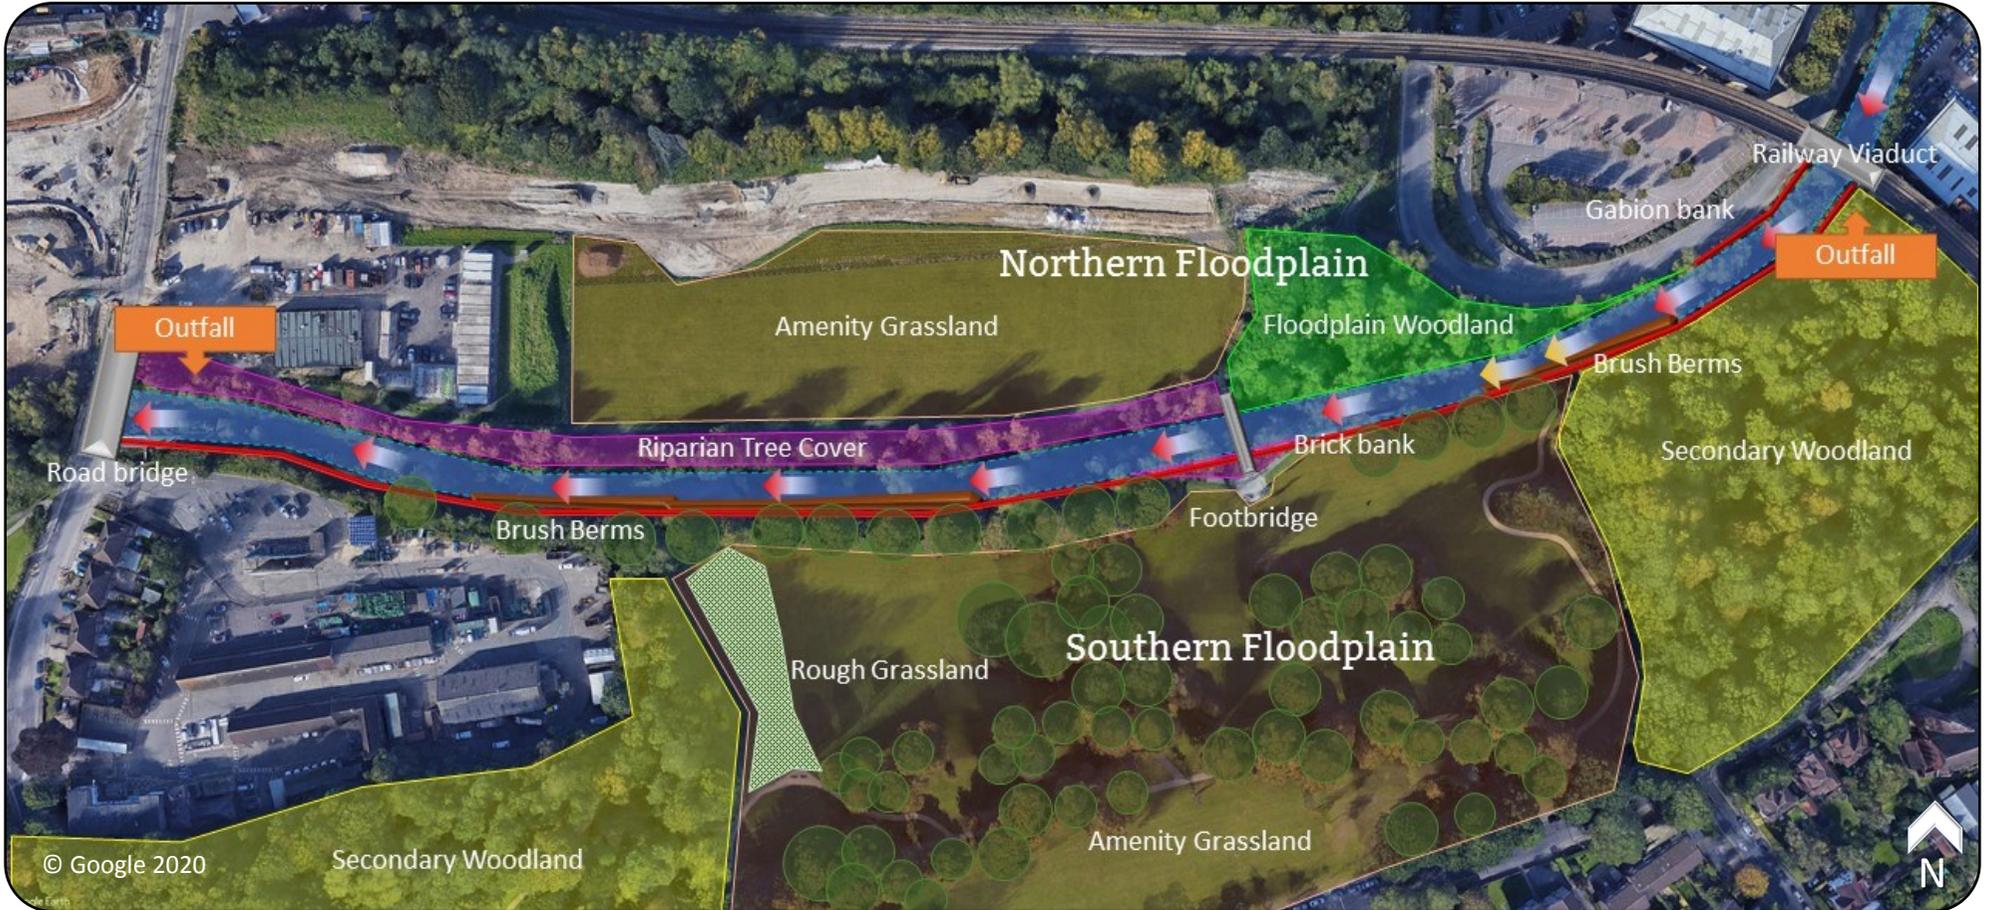
Oxhey Park habitat map

Legend:

- 1

Bank revetment
- 2

Floodplain Woodland
- 3

Formal trees
- 4

Secondary Woodland
- 5

Amenity Grassland
- 6

Rough Grassland
- Flowing Water
- Wooded Debris Feature

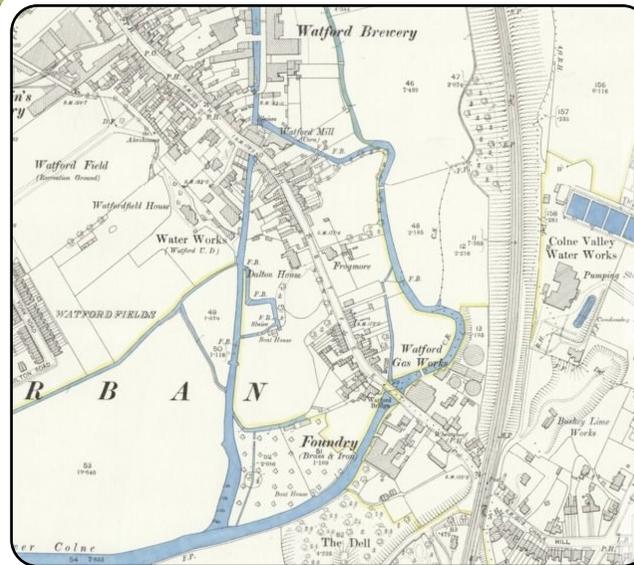
Ordnance Survey 25-inch map. Hertfordshire Sheet XLIV.6 1896 (detail). Showing the location of the Watford Cut and main river Colne.

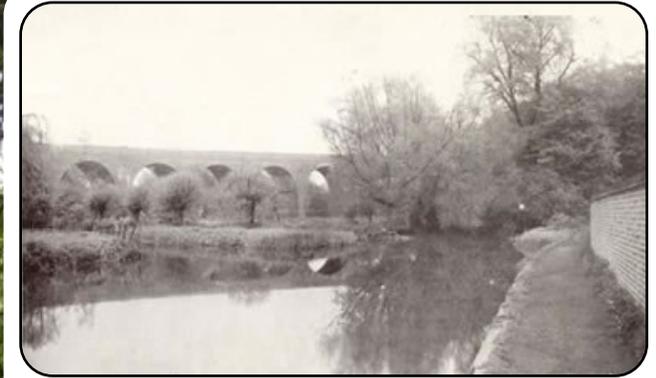
(Above) The Watford Cut merging with the main river in the early 1900s.

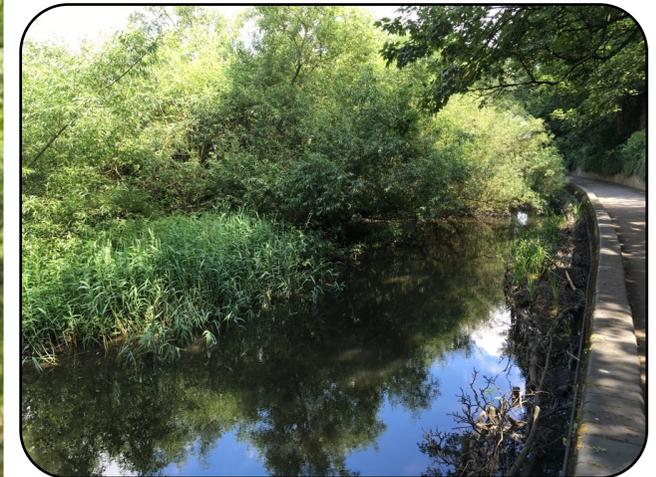
(Above) The same location today.

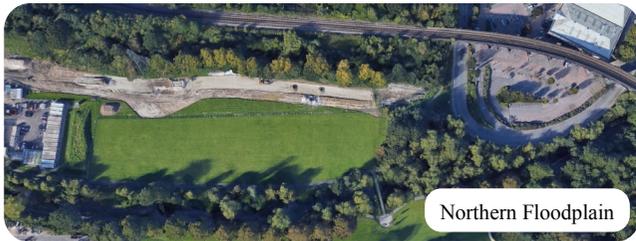
The majority of the Northern Floodplain is in flood zone 3 and is of lower topography than the southern floodplain. This area of the park can be inundated with water as river levels rise and generally provides wetter habitat than the land to the south of the river corridor.

The eastern compartment of the northern floodplain has been developed in recent years. The compartment once provided extensive floodplain habitat and was the location where the Watford Cut converged with the main River Colne. Much of this area is no longer within the boundaries of the park and is now comprised of a car park and a section of the Dalston Way. A small fragment of the former landscape still exists and is comprised of low-lying mudflats with extensive beds of Crack Willow. The area would have once provided a more extensive wetland, but declining water levels in recent times and the infilling of the Watford Cut have altered this part of the landscape permanently. Today the compartment offers an area of regionally scarce floodplain woodland and a secluded refuge for wildlife which contrasts the formal nature of the rest of the park.

The central and western compartments of the northern floodplain are comprised of amenity grassland and are dry in nature with poor connectivity to the river corridor. A thin, wooded fringe of mixed deciduous trees and shrubs lines the river corridor, providing a buffer strip between the intensively mown grass and the natural river corridor. These compartments are currently being developed to provide the Oxhey Activity Park which will provide recreation facilities for skateboarding, scooters, blading, mountain bikes and BMX.

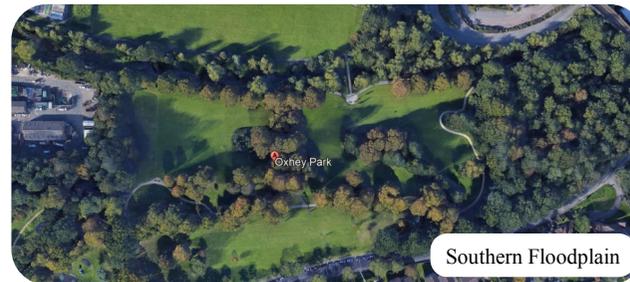
Southern Floodplain

The southern floodplain is comprised primarily of amenity grassland that slopes from the south of the park towards the river corridor. The grassland is interspersed by tree lines of native and ornamental species, small copses, ancient parkland trees, patches of scrub and rough grassland. Due to the sloping and elevated nature of the park, only a small portion of land, comprised of a footpath and narrow strip of grass, falls within the flood zone of the river. This factor, coupled with the formal nature of the park, means that there are few opportunities for wetland habitat creation or enhancement in this area.

One of the notable features of the Southern floodplain is a secondary woodland known as 'The Dell'. The Dell is dominated by Sycamore and Ash in the canopy with occasional Beech, Pendunculate Oak and Wild Cherry. Elder and Wych Elm are prominent in the understorey with occasional patches of Holly. Dog's Mercury is abundant in the ground flora with Wood False-brome, Ivy, Rough Meadow-grass, Cow Parsley, Stinging Nettle, and Enchanter's Nightshade in addition to more notable species such as Wood Sedge.

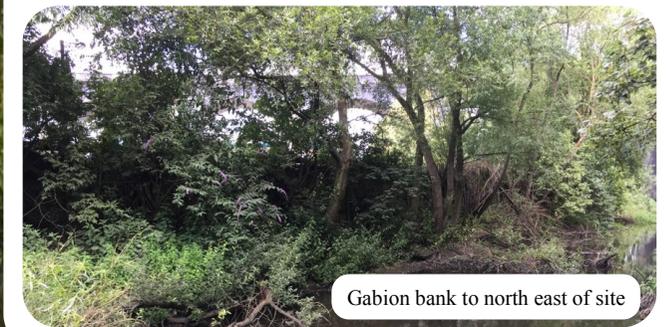
The northern bank of the river varies in its composition throughout the site. Towards the north east of the site, the riverbank is comprised of a vertical gabion wall of around three meters in height. Despite its artificial nature, silt and sediment has accumulated to form a bench at the toe of the bank that has become rapidly colonised by crack willow. Despite the willows over shading the river to a certain degree, they work to provide a more natural edge to the corridor and offer far better structural habitat than the gabion wall does.

Moving downstream towards to centre of the site, the bank is comprised of low lying (<1m) mudflats that extend up to 50 meters away from the river corridor. The mudflats are densely populated with crack willows which overhang the channel and provide an area of cover which contrasts the sparsely vegetated southern bank of the river. Extensive areas of tall herbs and grasses are also present along the river bank, with traces of emergent vegetation at the toe of the bank.

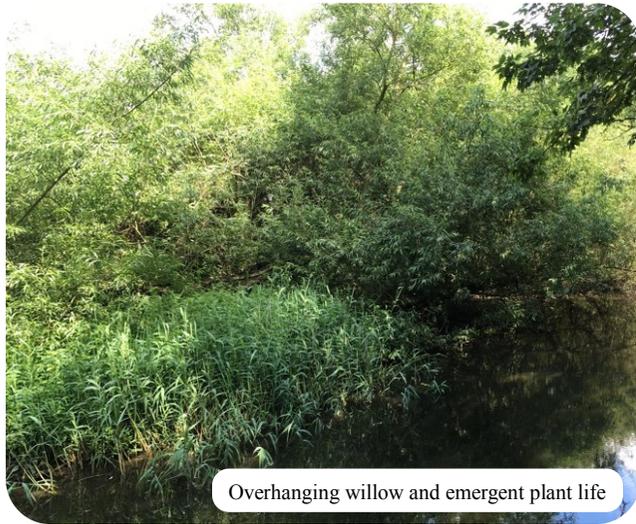
Overhanging willow and emergent plant life

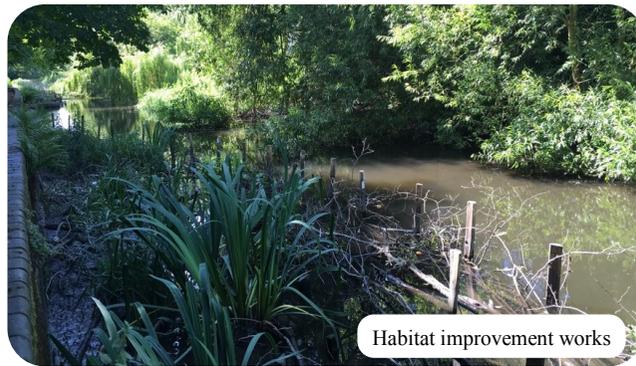
Habitat improvement works

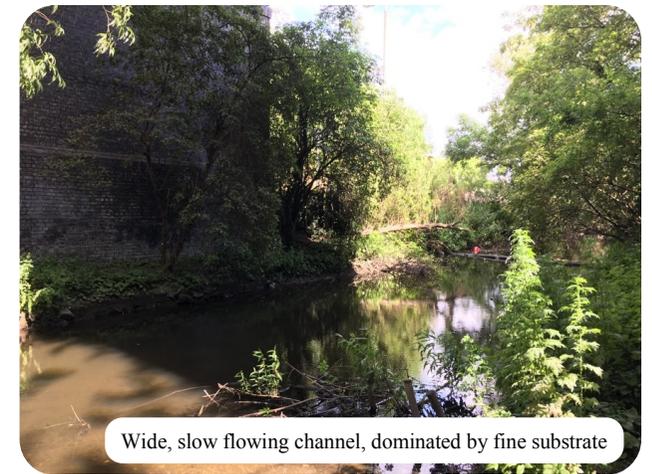
Wide, slow flowing channel, dominated by fine substrate

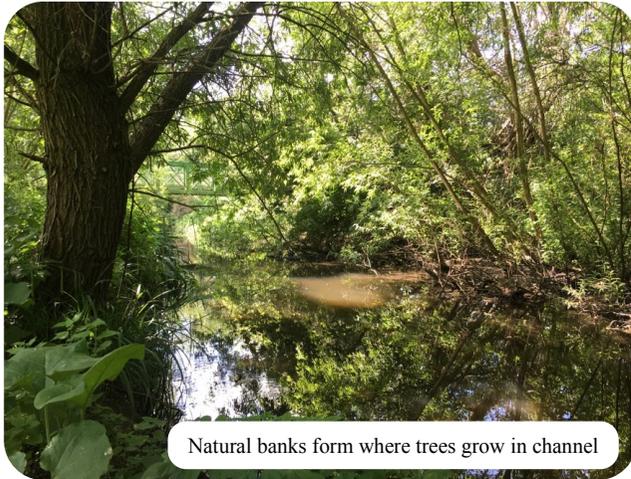
Natural banks form where trees grow in channel

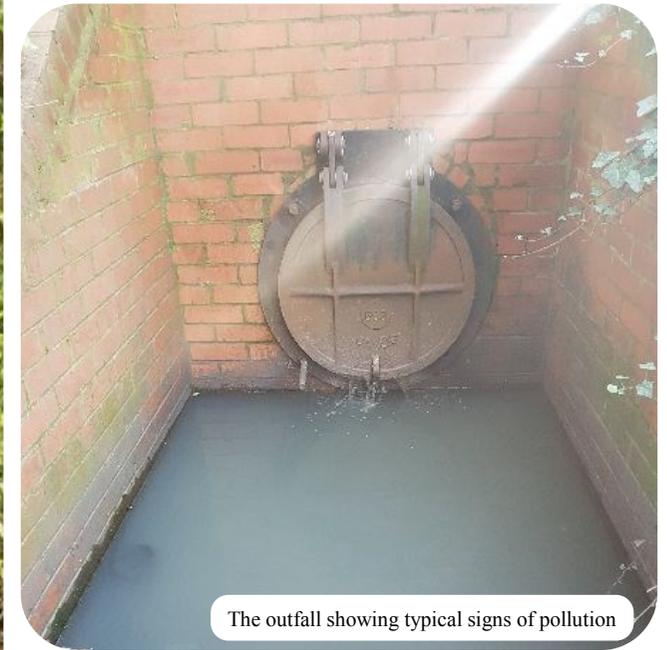
The outfall showing typical signs of pollution

Two outfalls are present along the river channel and their locations are illustrated on page 4. The outfall immediately downstream of the railway viaduct has been observed to regularly pollute the watercourse, with 18 pollution incidents being logged since 2016 (CVFC Pollution Monitoring Application, 2019). Site users regularly complain about the foul smell and visual signs of pollution as they enter the recreation ground from upstream.

The pollution can be attributed to domestic sewerage misconnections and links between the foul and surface water sewerage system. Thames Water have identified that the outfall is served by a catchment area of over 2,500 properties and have committed to conducting tracing exercises to locate the sources of pollution. Until the sources are identified and rectified, the river will continue to receive persistent pollution in this location. Poor water quality may have an even larger impact on the river at this site than poor habitat quality and is directly responsible for

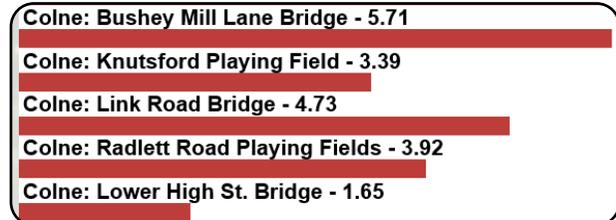
ARMI results for all Watford sites (upstream)

The monitoring site immediately upstream of Oxhey Park (Lower Highstreet Bridge) returns the poorest ARMI results in the Colne Catchment. The site scores an average of 1.67 and regularly breaches the trigger

levels set by the Environment Agency. Scores returned from all ARMI sites in Watford illustrate an overall trend in declining water quality as the river progresses through Watford.

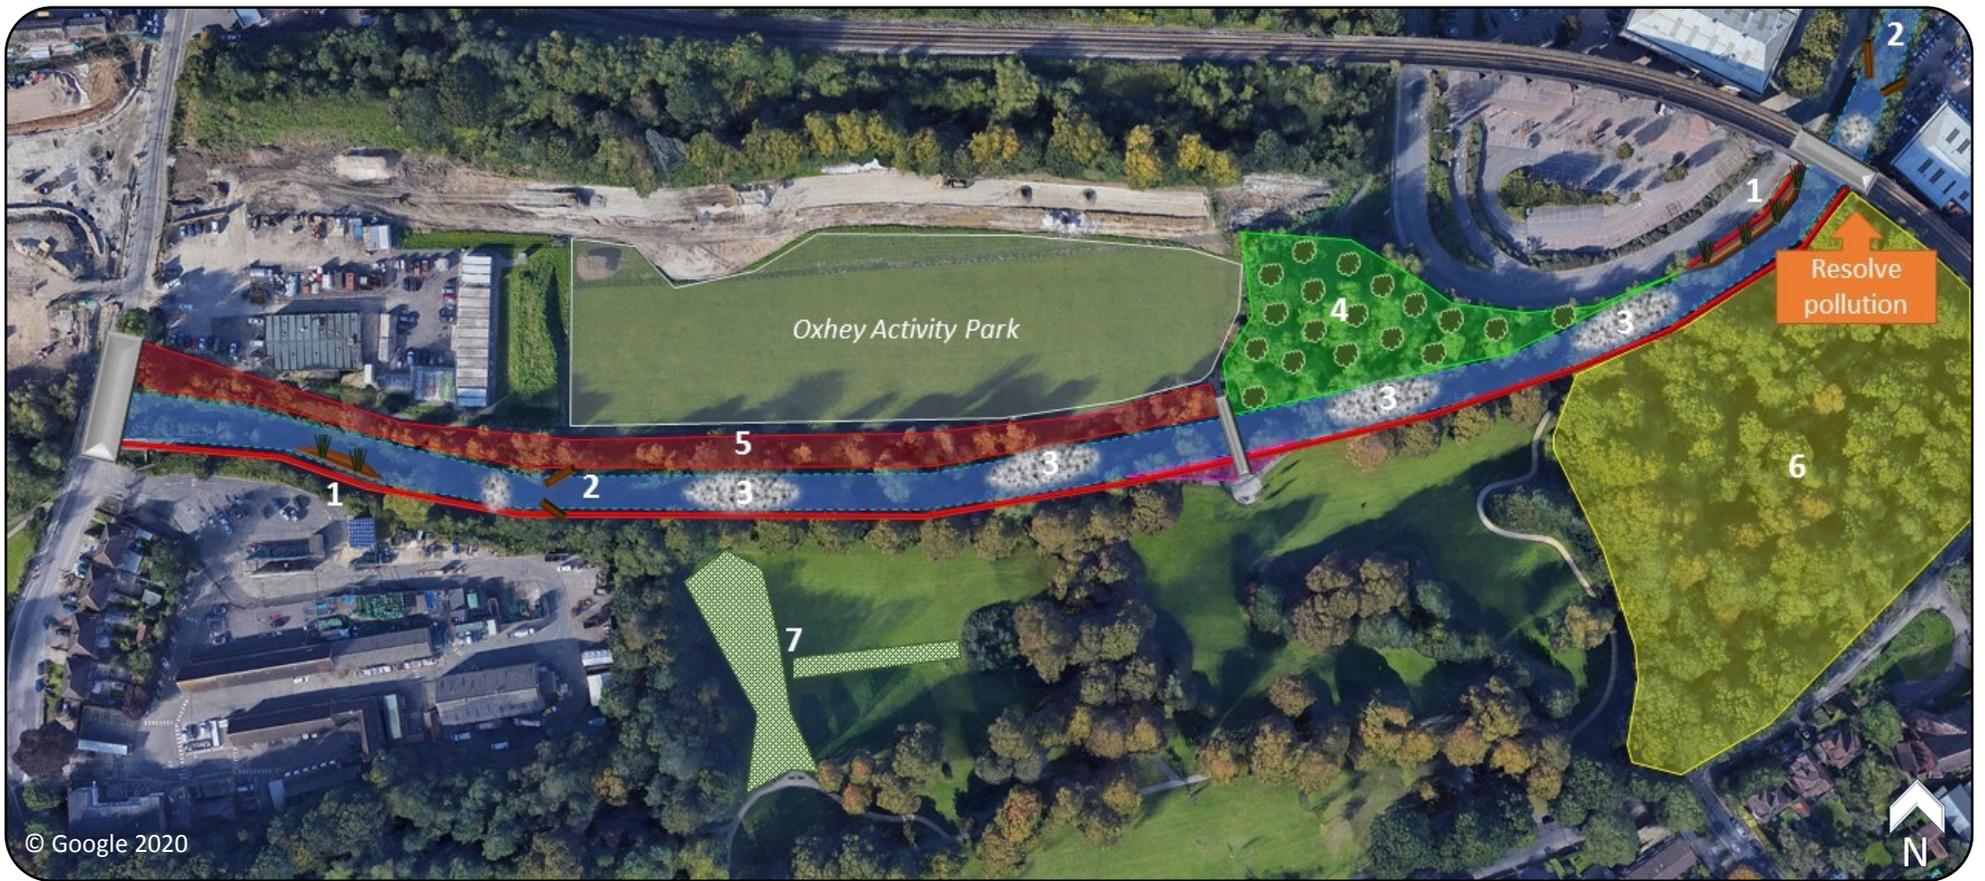
Legend:

1
Brush berm

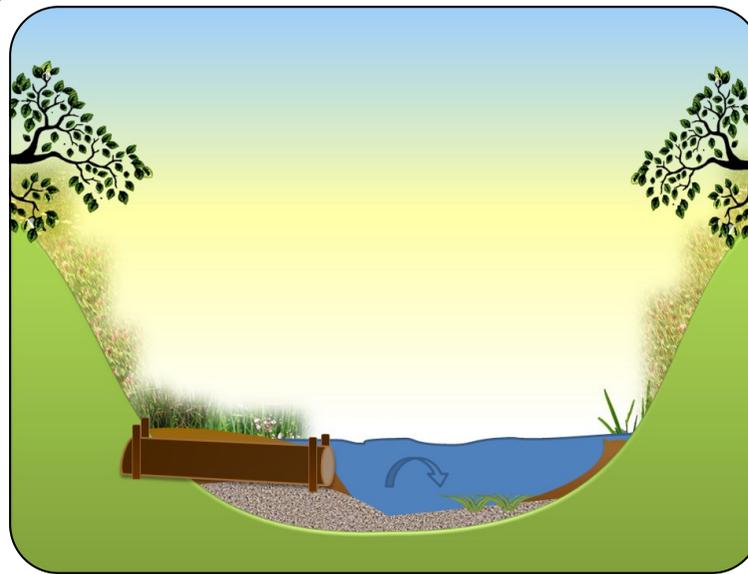
Flow deflectors are used to pinch the width of the river which reduces siltation, creates scour and facilitates a variety of different flow types.

They are created by securing tree trunks to the bed of the river with chestnut posts and galvanised steel wire. A pool feature can also be created downstream of each deflector's location to provide a variety of depths. Materials won from excavating pools can be repurposed to create riffles or side bars, which further increase physical habitat complexity.

1. In order to ensure that flow deflectors do not cause blockages or excessively limit the water storage capacity of the channel they should be installed follow these specifications:
2. Deflectors should extend no further than one third of the width of the river channel in any location.
3. Deflectors should be no higher than 25% of the river's banks river in any location they are placed.
4. All deflectors should be installed via the method specified below.

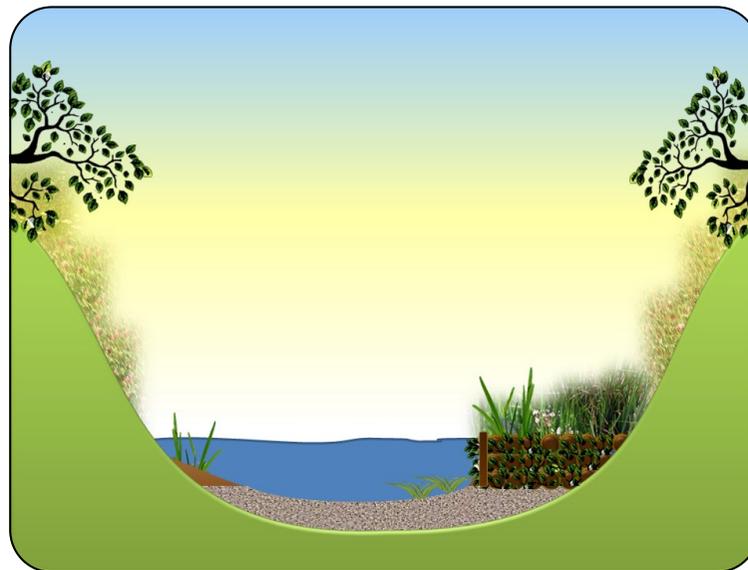
Brush berms can also be installed to pinch the width of the river and can be used to mimic natural sinuosity. They provide useful low lying areas for aquatic plants to colonise in addition to providing physical structures for aquatic wildlife to shelter.

They are created by using tree branches to reshape the river, which are secured in place with chestnut posts and galvanised steel wire.

In order to ensure that brush berms do not cause blockages or excessively limit the water storage capacity of the channel they should be installed following these specifications:

5. Each row of chestnut posts is hammered down with a fencing maul, permanently securing all material positioned in the berm under the loops of strained wire they are attached to.
6. Finally the berm is checked for material that may come loose and cause blockages elsewhere in the river channel. Excess wood sticking out from the berm is also trimmed to improve hydrodynamics.

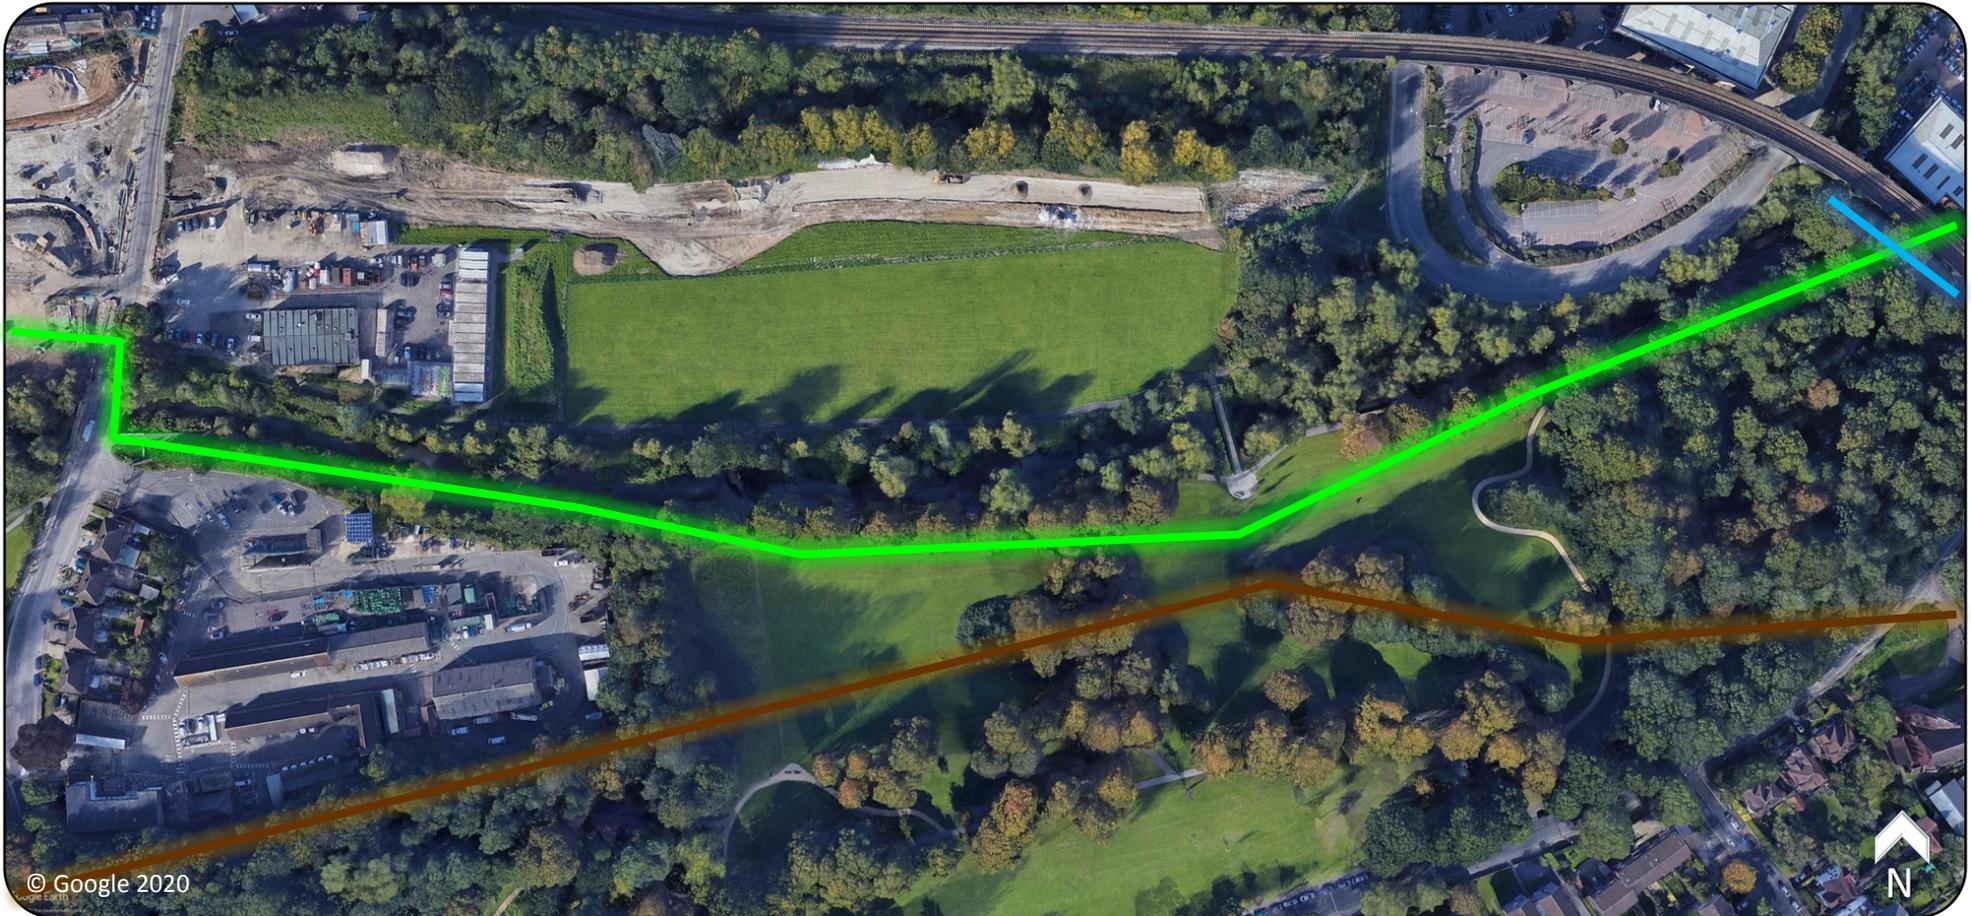
Sewers—Surface

Sewers—Foul

The locations of utilities should be interpreted as an initial guide in order to inform further design work. It is recommended that a new utilities search is conducted by the appointed contractor before construction works commence

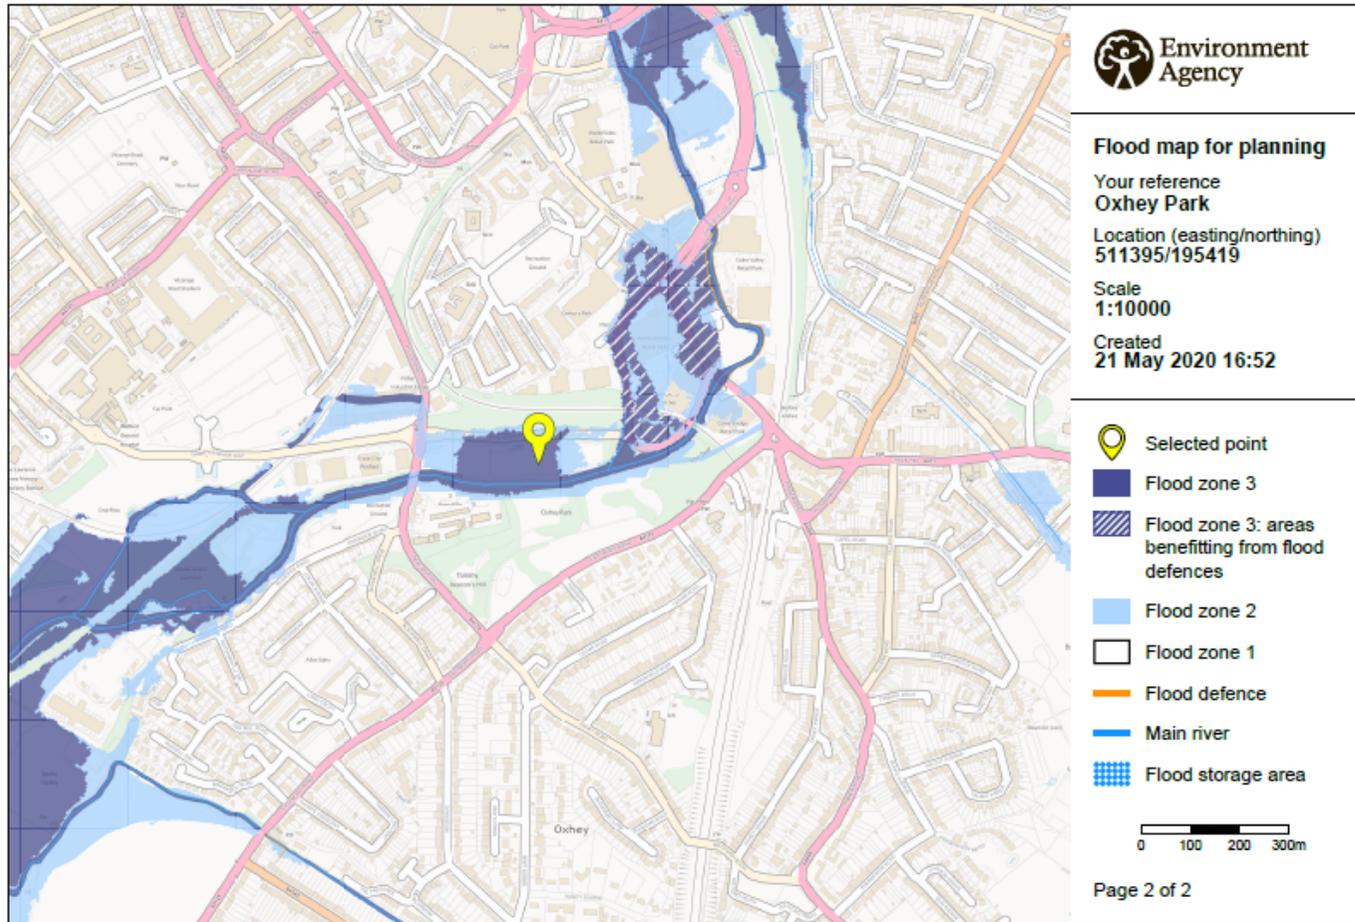
The majority of the northern floodplain is in flood zone 3, with some areas benefitting from flood defences. The provision of a wet woodland and ponds within this area will aid natural flood risk management.

Any works proposed within the main river channel should not encourage out of channel flow and should not cause any significant obstruction or impoundment.
