Timberlake Allotments Open Space

River Improvement Plan

**WATFORD
BOROUGH
COUNCIL**

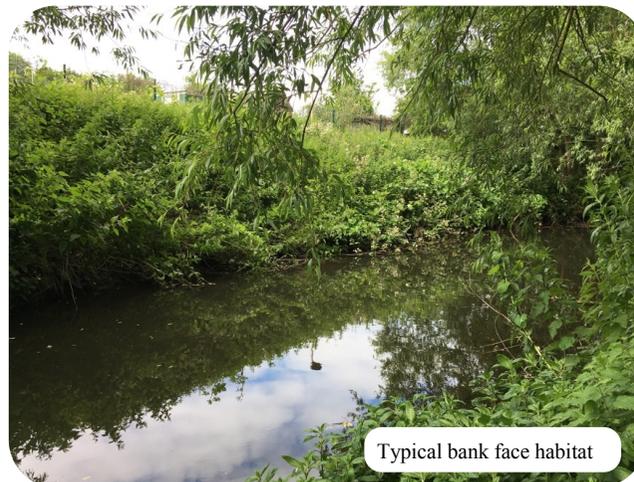
The banks of the river are comprised primarily of earth, with occasional silt bars lining the bottom third of the bank face. Although they have been reshaped, they are not enforced with any hard revetment. The profile of the banks ranges from steep to gentle.

Steeper areas of river bank are less favourable for the colonisation of aquatic plant species. Marginal features such as berms, unvegetated side bars and vegetated sidebars are present throughout the watercourse, which demonstrates that the river is slowly recovering from the effects of modification. Although sediment is beginning to stabilise in the river's margins, large areas of loose silt are also present,

showing that intervention is required to catalyse the river's recovery.

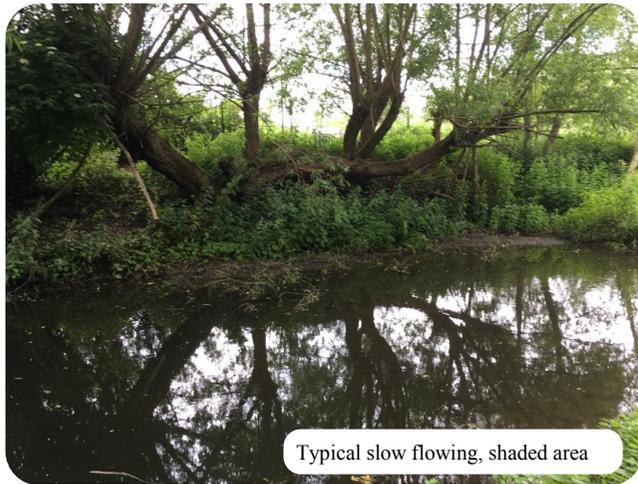
Typical slow flowing, shaded area

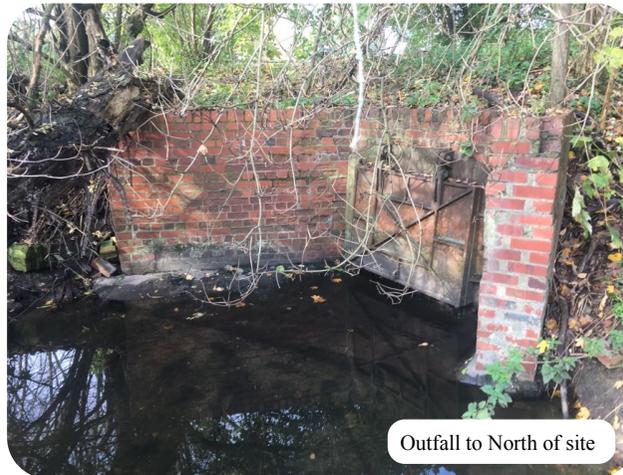
Outfall to North of site

Two outfalls are present along the river channel but have not been observed to regularly pollute the river. The locations of the outfalls are illustrated on page 4.

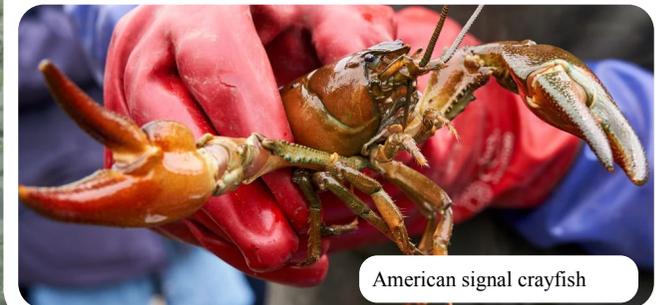
American signal crayfish burrows were found throughout the site. The species is common place in the Colne Catchment. Crayfish Burrowing mobilises sediment which has a negative impact on both water quality and habitat. The species should be monitored via the Rediscovering the River Colne Environmental Monitoring Project.

American signal crayfish

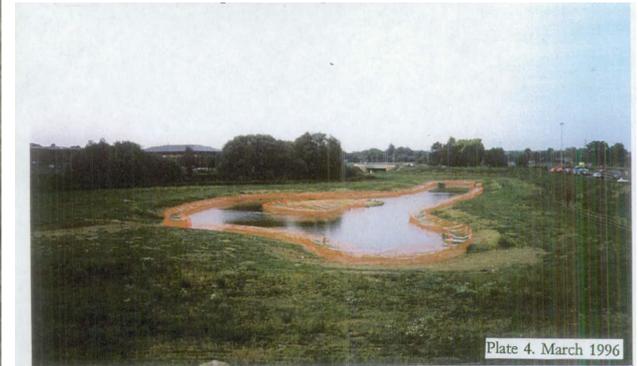
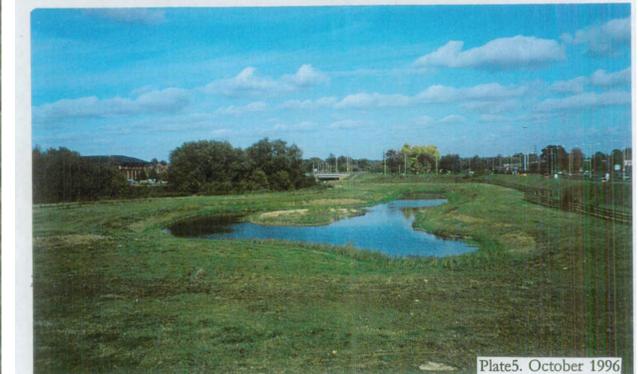
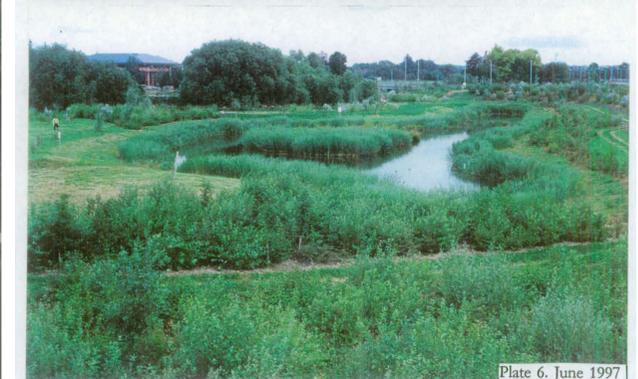
Backwater maturation 1996-1997

In 1996 a habitat enhancement scheme was implemented to improve the pond by connecting it to the main river as a backwater. This consisted of creating a new inlet for the pond with a two staged profile. The bed level of the channel and pond were designed to match those of the connection point with the main

river. This allowed water from the main river to fill the ponds without impact on surface water flows. This enabled a connection between the river and pond throughout the year, allowing fish and invertebrates to migrate freely between them. The average depth within the backwater at normal flows was 1m. A 1m wide marginal shelf was also installed within the pond to increase habitat complexity within the backwater itself.

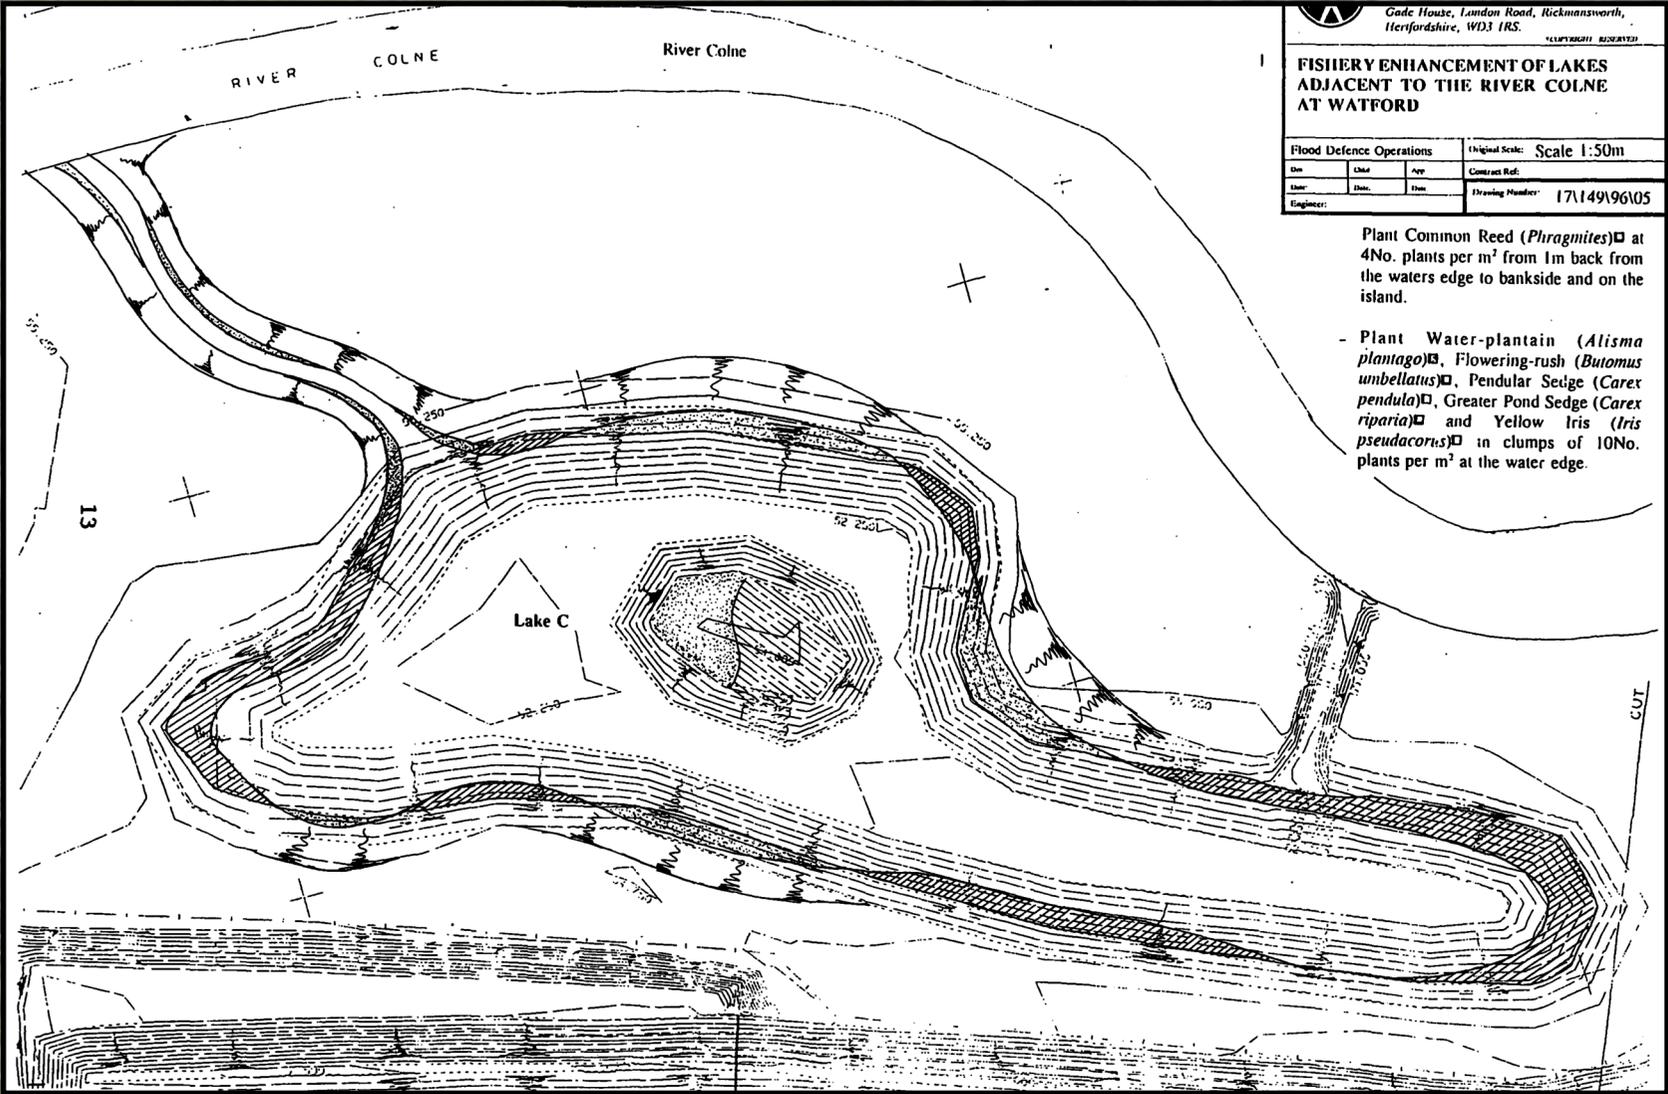
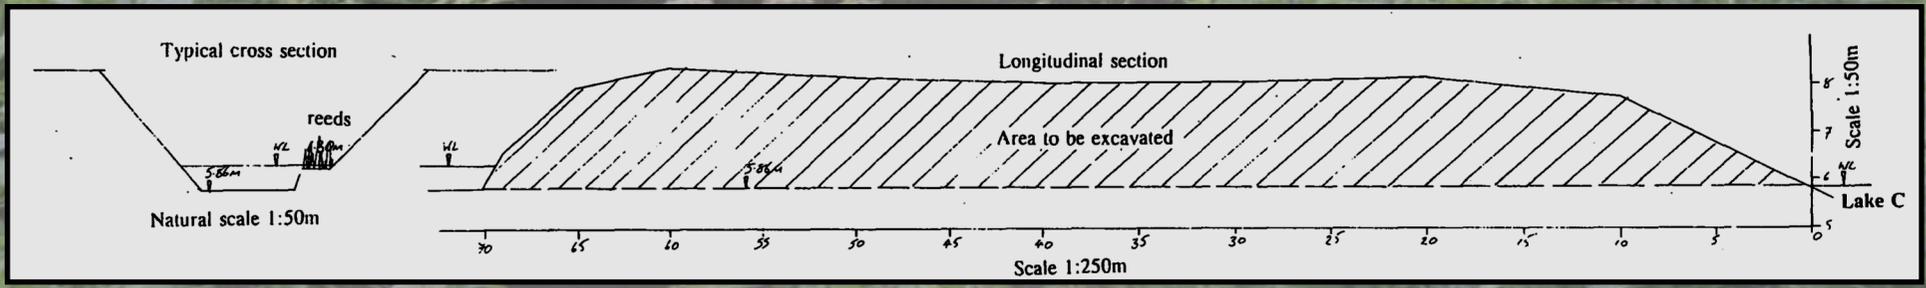
FISHERY ENHANCEMENT OF LAKES ADJACENT TO THE RIVER COLNE AT WATFORD

Plant Common Reed (*Phragmites*) at 4No. plants per m² from 1m back from the waters edge to bankside and on the island.

- Plant Water-plantain (*Alisma plantago*), Flowering-rush (*Butomus umbellatus*), Pendular Sedge (*Carex pendula*), Greater Pond Sedge (*Carex riparia*) and Yellow Iris (*Iris pseudacorus*) in clumps of 10No. plants per m² at the water edge.

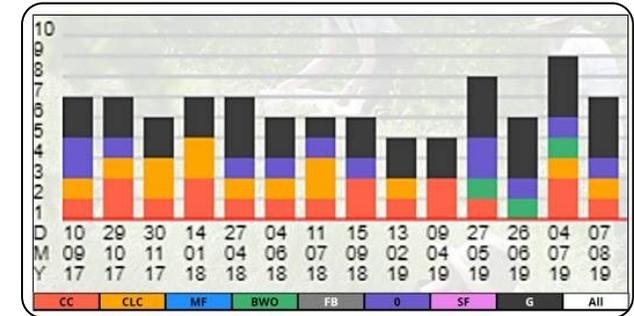
Bushey Mill Lane ARMI results (1.2km upstream)

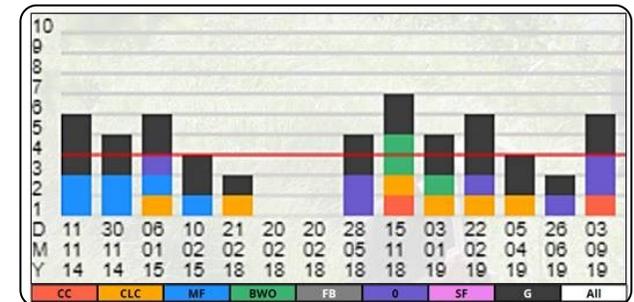
Knutsford Playing Fields ARMI results (0.9km upstream)

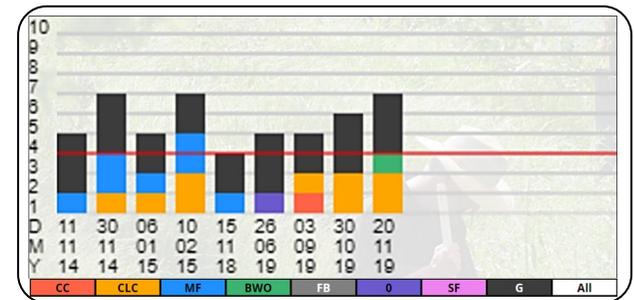
Timberlake Allotments ARMI results

Timberlake allotments returns an average ARMI score of 4.43. This is a slightly higher score than the

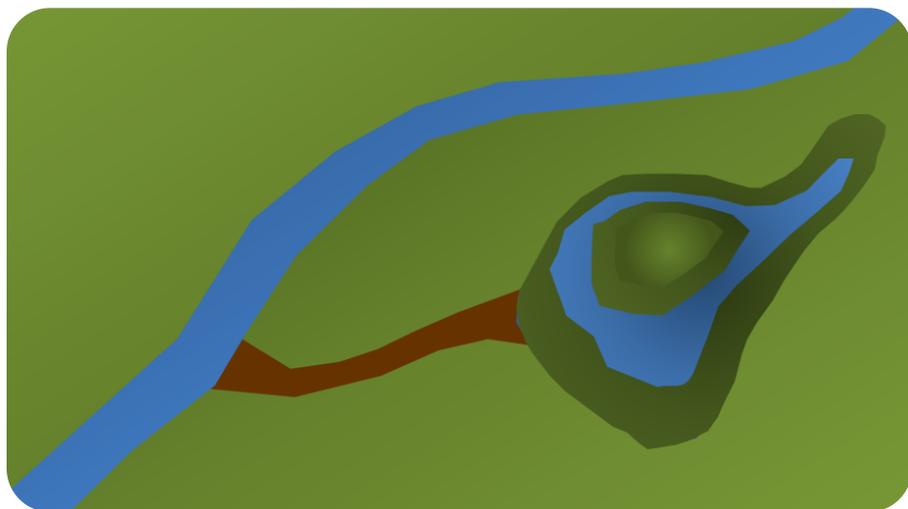
Before Restoration:

- The backwater is currently disconnected from the main river due to the accumulation of organic debris and silt in the pond area and outlet channel.
- The siltation of the outlet channel and pond has raised the bed level of the features, providing a bathymetric barrier between the pond and main river.
- The outlet channel is impeded further by the presence of a reedbed that blocks its connection with the pond area.
- Due to a lack of management, reeds are encroaching to the centre of the pond, reducing the area of open water and further raising the bathymetric level of the pond.

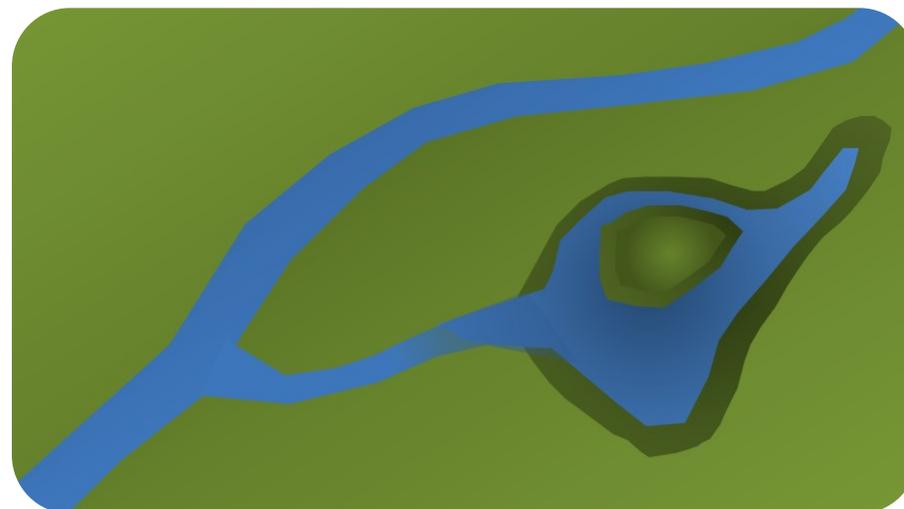
After Restoration:

- The bed level of the pond and outlet channel is lowered to match the bed level of the adjacent river channel.
- Water is able to back up the channel from the main river, providing a constant connection between the two features.
- The reed bed is reduced to create a larger area of open water and to prevent the outlet channel from blocking.
- The reedbed is be cut on rotation, annually, to maintain the balance between vegetated areas and open water.
- If a connection with the river cannot be facilitated, the pond should be enhanced in isolation via desilting and reed bed management to prevent it from drying out further.

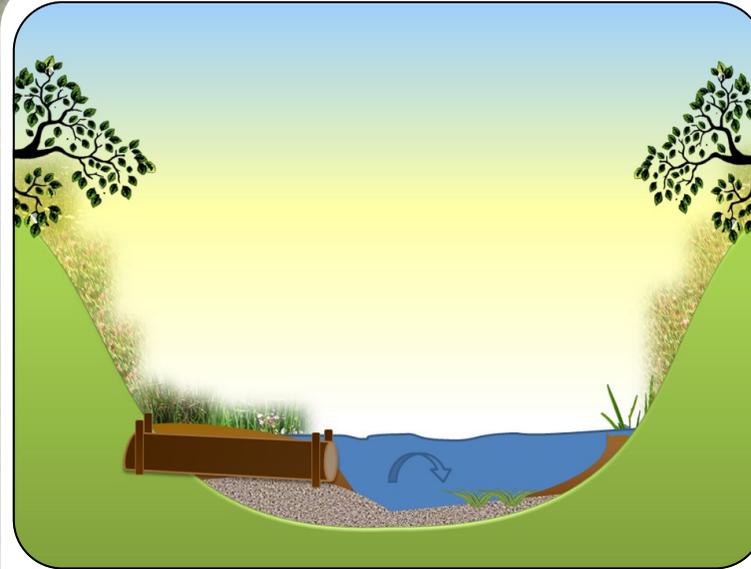
Flow deflectors are used to pinch the width of the river which reduces siltation, creates scour and facilitates a variety of different flow types.

They are created by securing tree trunks to the bed of the river with chestnut posts and galvanised steel wire. A pool feature can also be created downstream of each deflector's location to provide a variety of depths. Materials won from excavating pools can be repurposed to create riffles or side bars, which further increase physical habitat complexity.

1. In order to ensure that flow deflectors do not cause blockages or excessively limit the water storage capacity of the channel they should be installed follow these specifications:
2. Deflectors should extend no further than one third of the width of

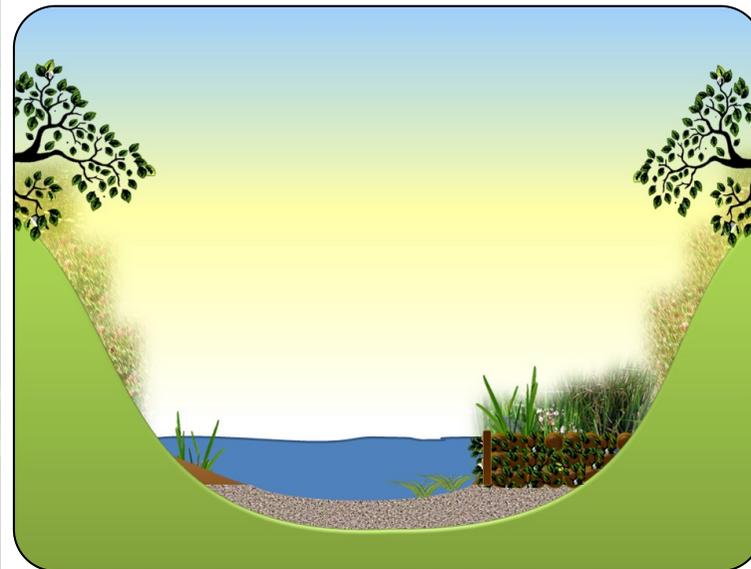
Brush berms can also be installed to pinch the width of the river and can be used to mimic natural sinuosity. They provide useful low lying areas for aquatic plants to colonise in addition to providing physical structures for aquatic wildlife to shelter.

They are created by using tree branches to reshape the river, which are secured in place with chestnut posts and galvanised steel wire.

In order to ensure that brush berms do not cause blockages or excessively limit the water storage capacity of the channel they should be installed following these specifications:

6. Finally the berm is checked for material that may come loose and cause blockages elsewhere in the river channel. Excess wood sticking out from the berm is also trimmed to improve hydrodynamics.

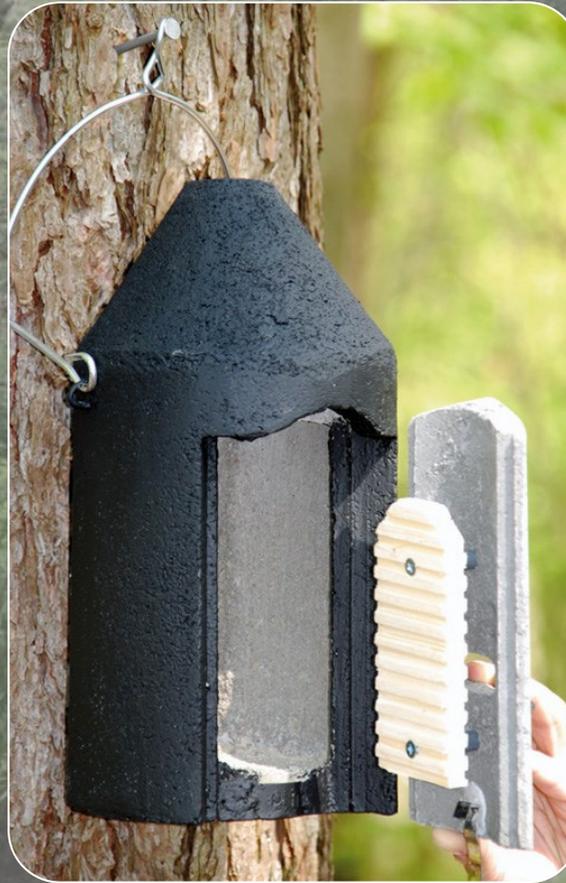
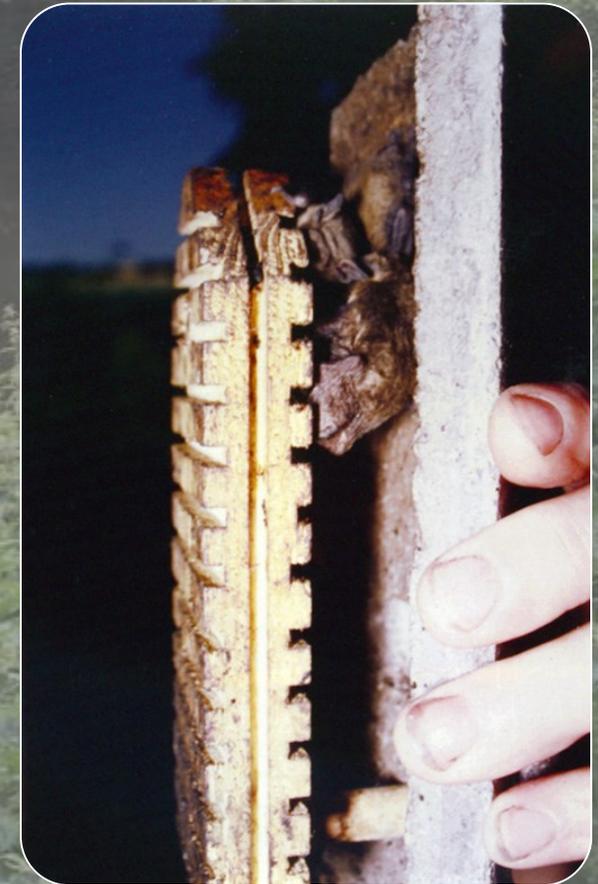
Schwegler 2F Bat Boxes

The box has a special double front panel, made of long-term resistant, grooved wooden boards, which creates a particularly popular and readily acceptable roost for crevice-inhabiting Bats, for example Nathusius' Pipistrelle, Daubenton's and Pipistrelle Bats.

The bat box can be easily converted into a 2F Bat Box without double front panel or a 2M Nest Box for Birds at any time. The front panel can be removed for inspection and cleaning.

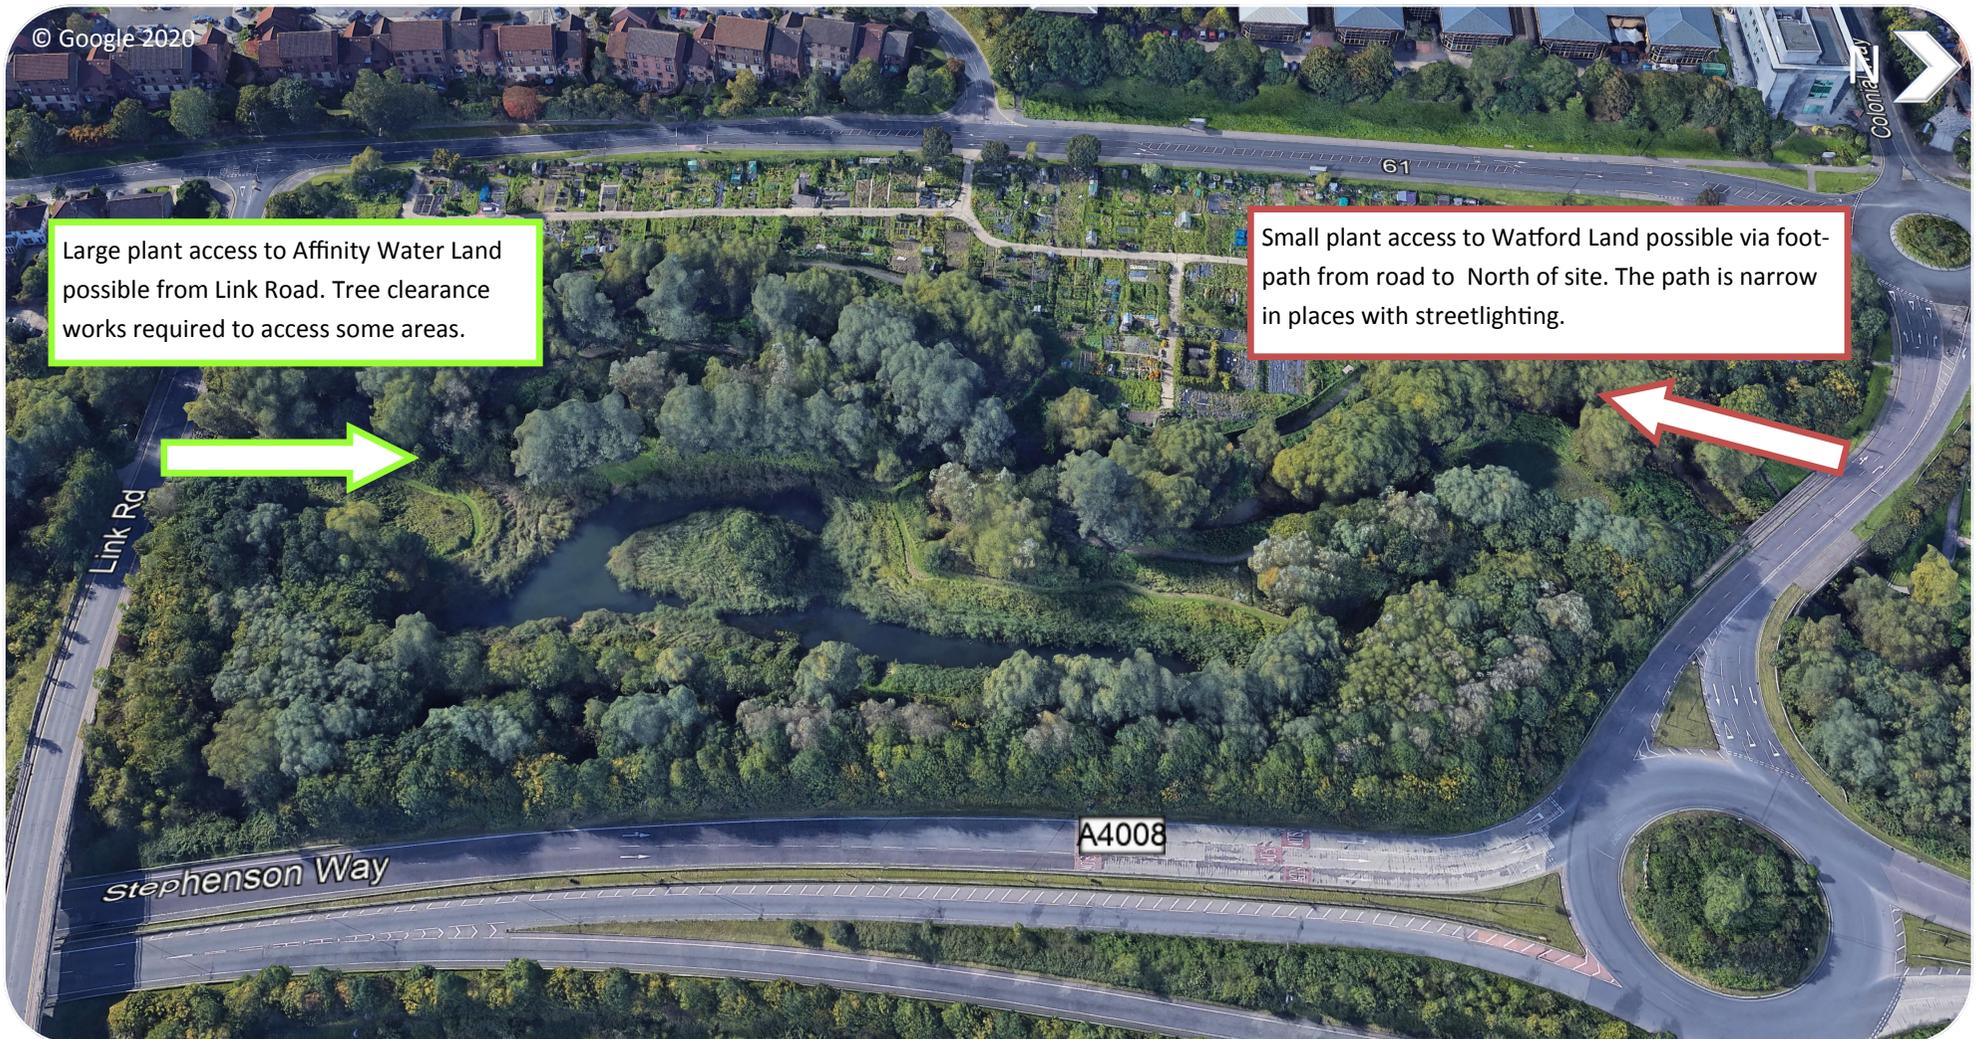
Site Access Plan

The Western floodplain is accessible for small plant from the road and car park to the north of the site. It should be noted that street lighting is present along the footpath which will limit the size of plant that can access. The Eastern floodplain is accessible for large plant from Link Road, but tree clearance may be required.

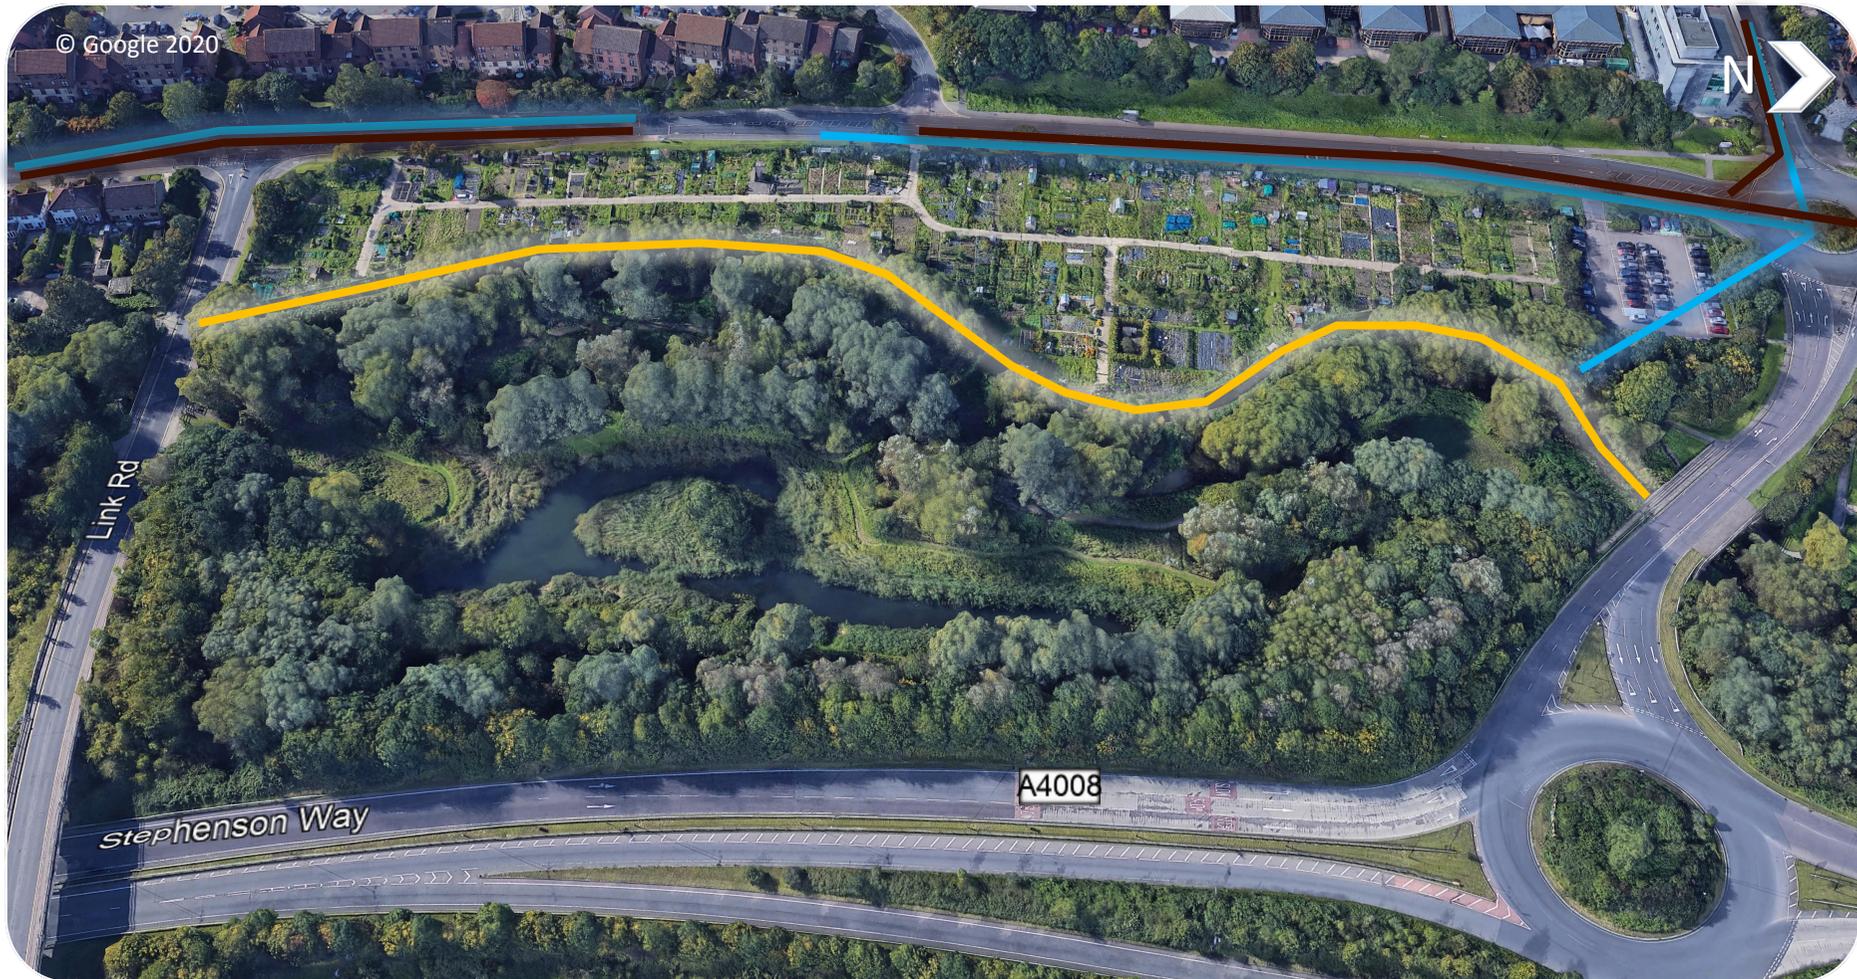
Utilities Search

The locations of utilities should be interpreted as an initial guide in order to inform further design work. It is recommended that a new utilities search is conducted by the appointed contractor before construction works commence.

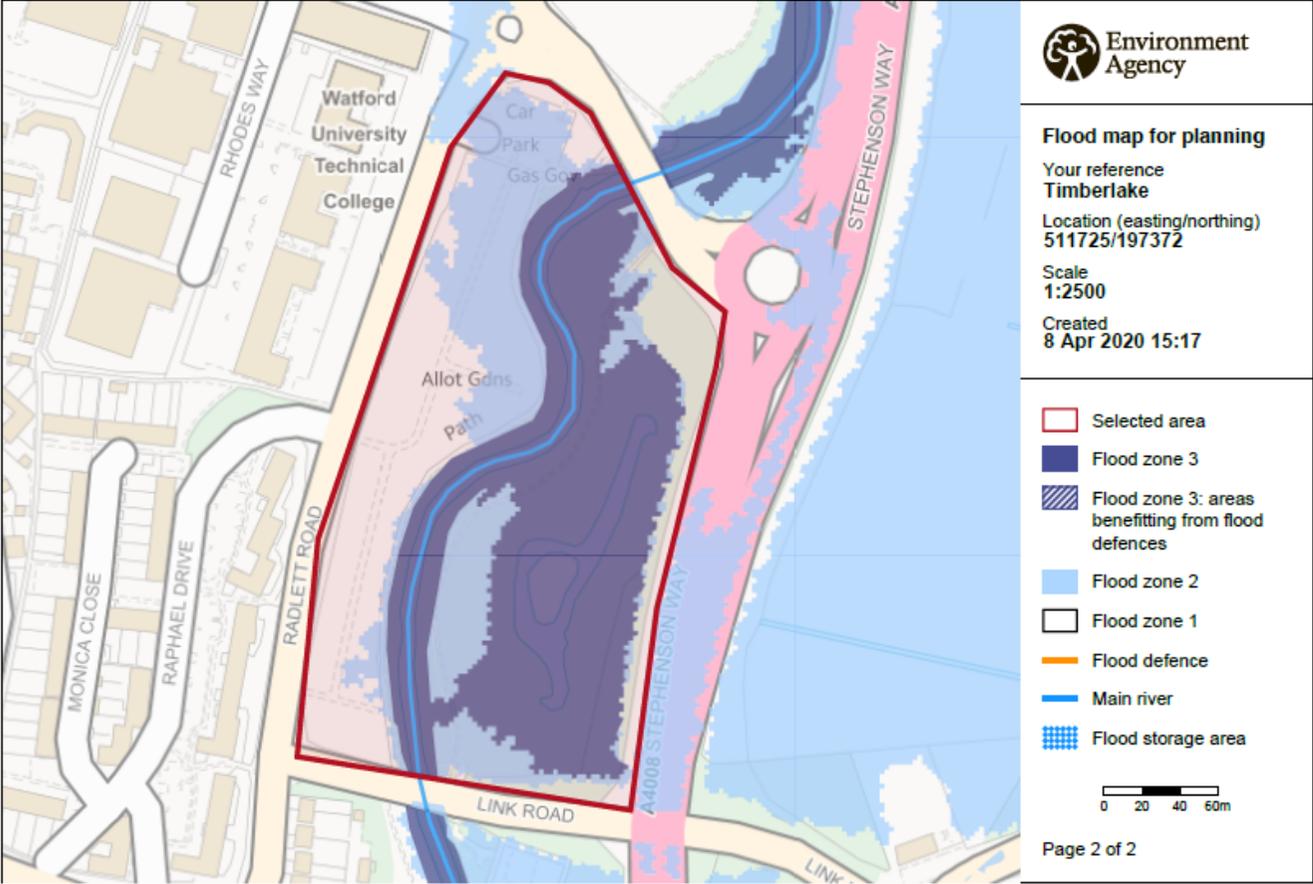
Flood map for planning

Any works proposed within the main river channel should not encourage out of channel flow and should not cause any significant obstruction or impoundment.
