Knutsford Playing Fields

River Improvement Plan

WATFORD
BOROUGH
COUNCIL

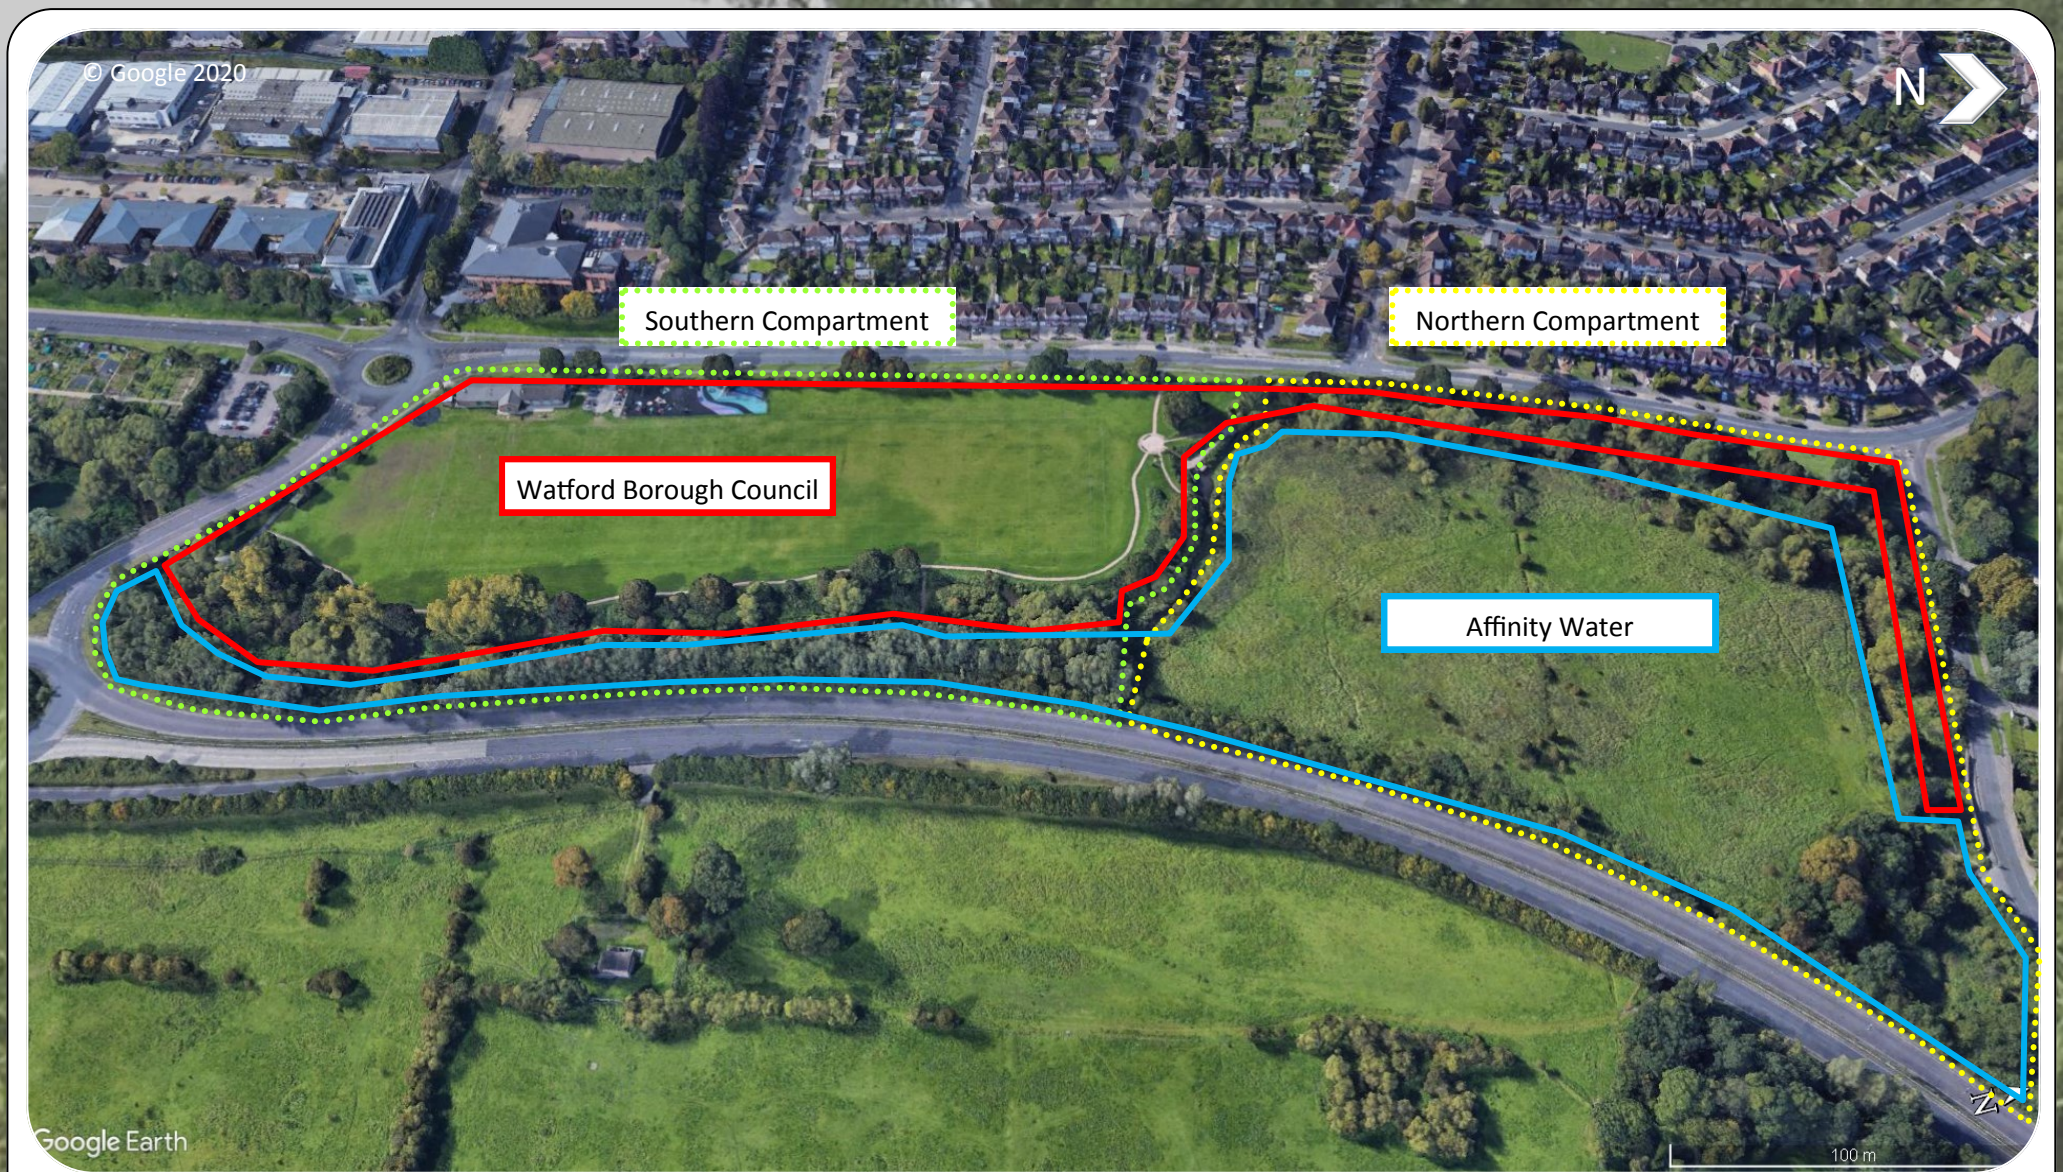
Site Plan

Knutsford Playing Fields land ownership

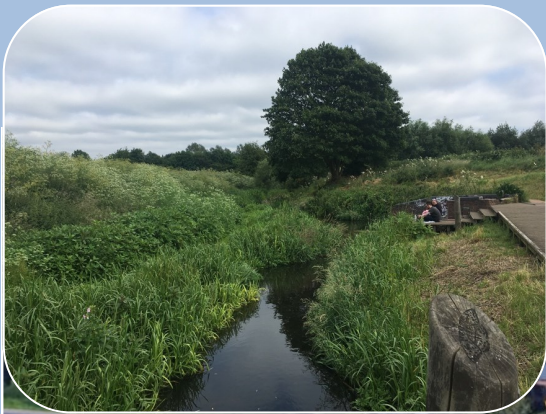
River is open and showing good signs of recovery

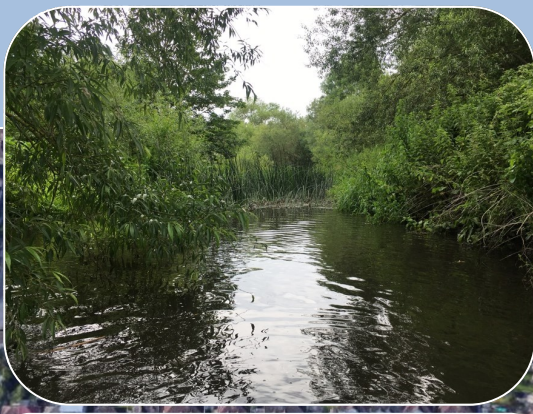
River is slow flowing and prone to siltation

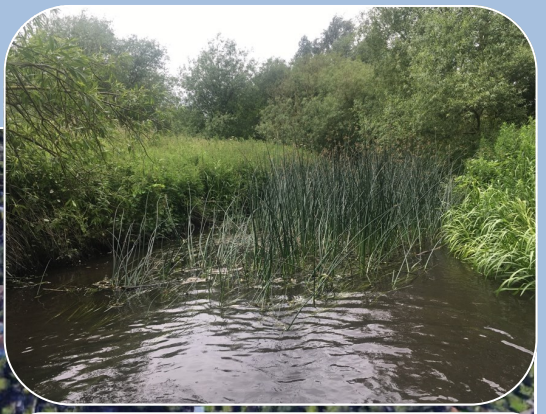
River choked where its profile is open and wide

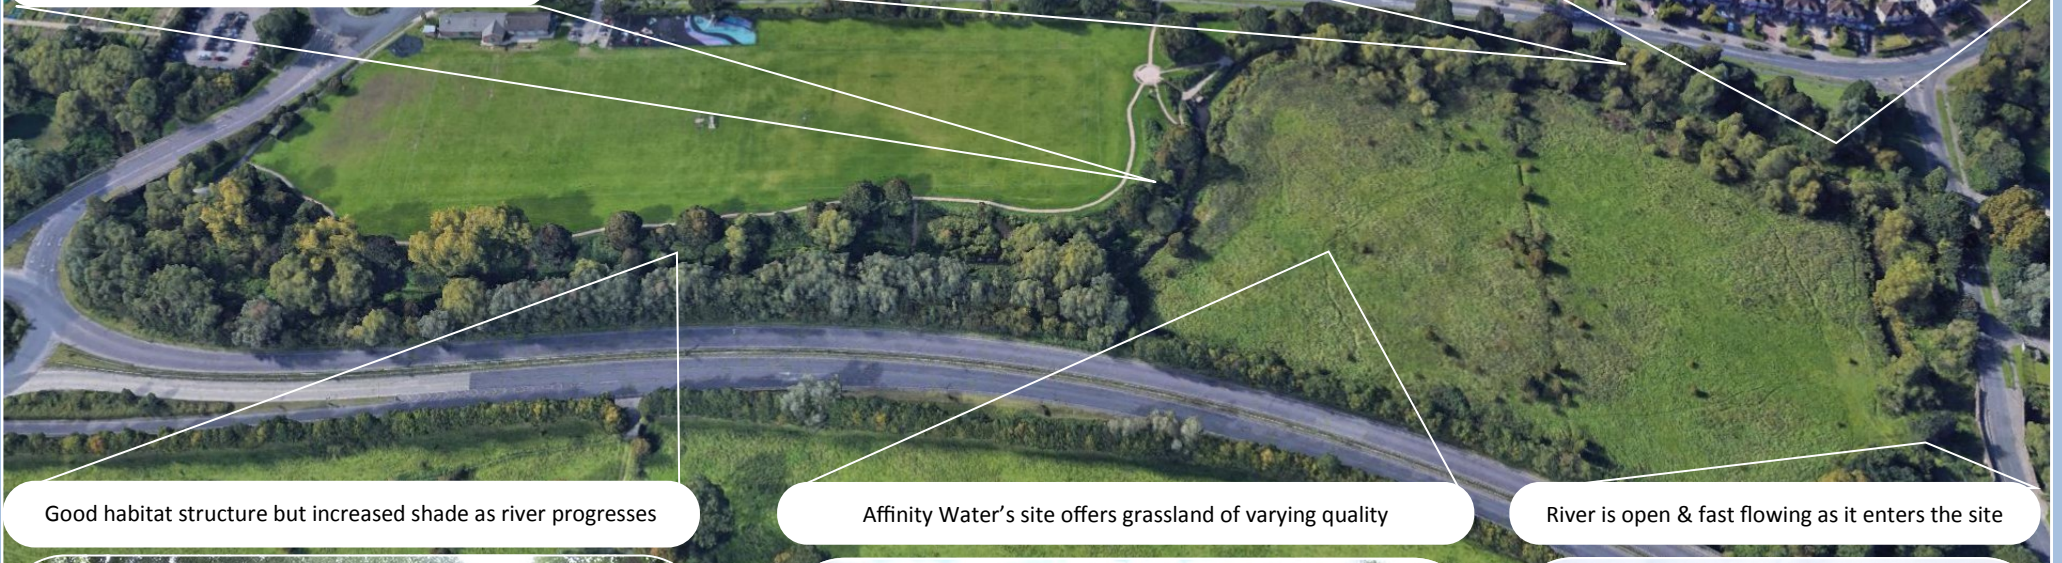
Good habitat structure but increased shade as river progresses

Affinity Water's site offers grassland of varying quality

River is open & fast flowing as it enters the site

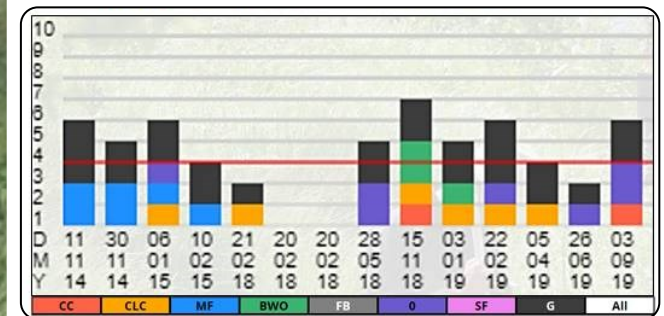
Knutsford Playing Fields ARMI results

Knutsford Playing Fields returns an average ARMI

score of 3.31. This is significantly lower than the monitoring site located immediately upstream at Bushy Mill Lane which returns an average score of 5.57. The difference between the two scores reflects a shift in water quality over a relatively short area of river. Changes in water quality can usually be attributed to a source of pollution.

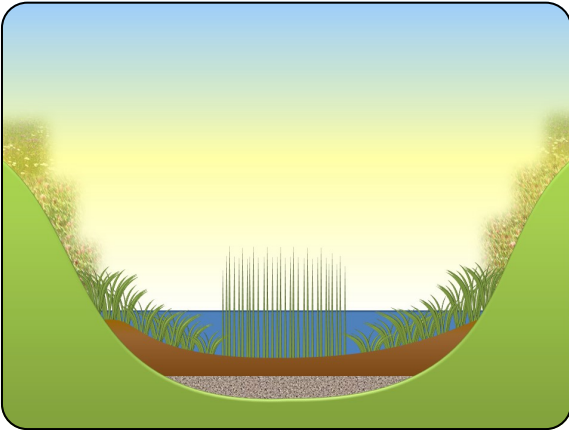
Due to the rivers modified profile and slow flowing nature, sunlit areas become choked with aquatic plant s.

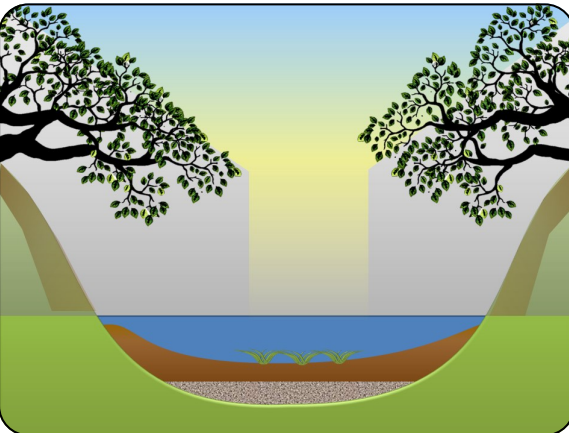
Over shading in some areas limit the plant life that is able to establish, resulting in bare banks and areas of loose silt covering the river's gravels.

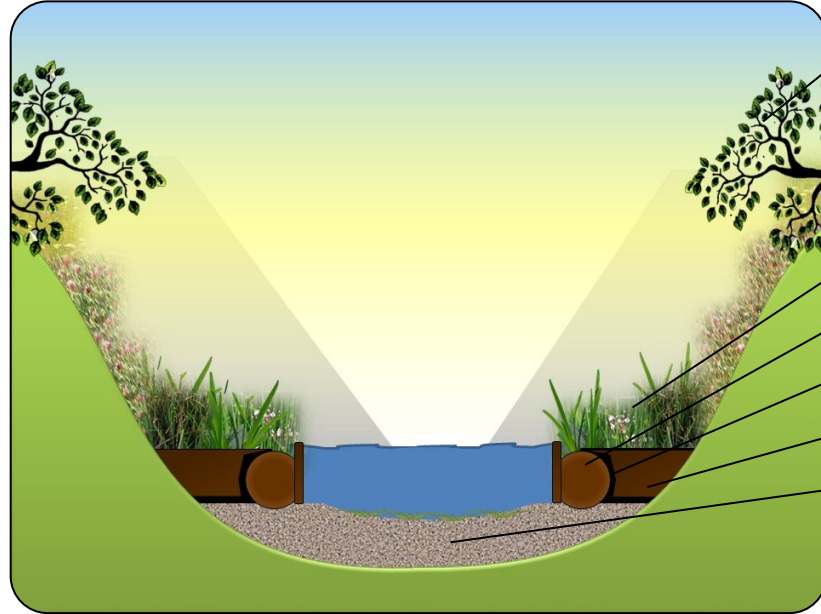
Low flow channels

60:40 light shade ratio

Pre planted coir pallets

The provision of a low flow channel will ensure that the river continues to offer good habitat and geomorphology during times of low flow. Faster flowing water in the centre of the channel will prevent siltation and the encroachment of undesirable plant species. A 60:40 light shade ratio will ensure the river receives the right amount of light for diverse aquatic plant communities to establish, whilst still providing important structural habitat.

The banks of the low flow channel should be low in profile, enabling the wider channel to be utilised for water storage during high flow events.

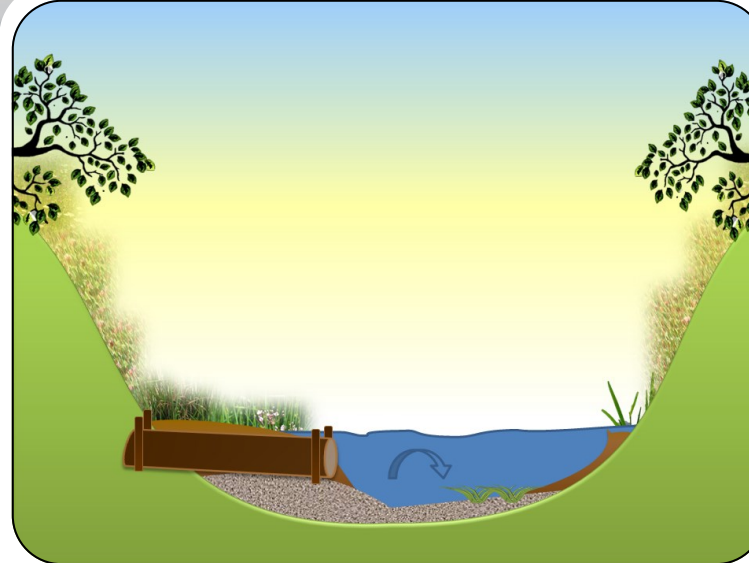
Flow deflectors are used to pinch the width of the river which reduces siltation, creates scour and facilitates a variety of different flow types.

They are created by securing tree trunks to the bed of the river with chestnut posts and galvanised steel wire. A pool feature can also be created downstream of each deflector's location to provide a variety of depths. Materials won from excavating pools can be repurposed to create riffles or side bars, which further increase physical habitat complexity.

1. In order to ensure that flow deflectors do not cause blockages or
excessively limit the water storage capacity of the channel they
should be installed follow these specifications:
2. Deflectors should extend no further than one third of the width of
the river channel in any location.
3. Deflectors should be no higher than 25% of the river's banks river
in any location they are placed.
4. All deflectors should be installed via the method specified below.

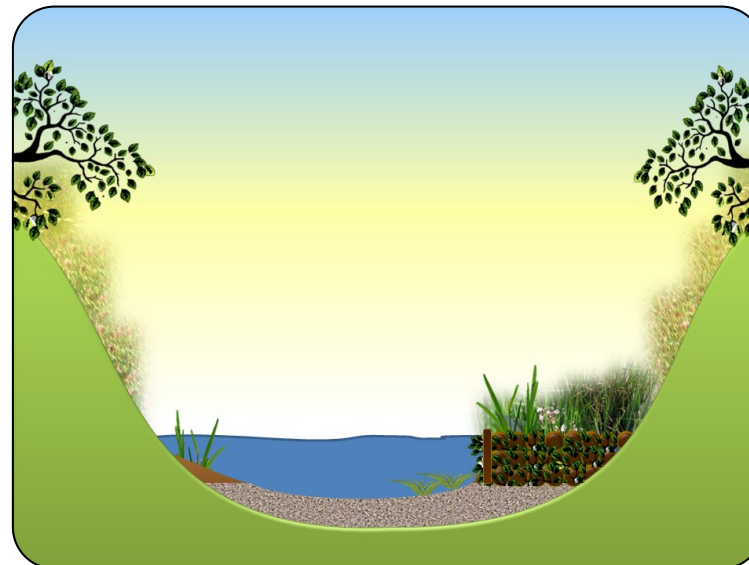
Brush berms can also be installed to pinch the width of the river and can be used to mimic natural sinuosity. They provide useful low lying areas for aquatic plants to colonise in addition to providing physical structures for aquatic wildlife to shelter.

They are created by using tree branches to reshape the river, which are secured in place with chestnut posts and galvanised steel wire.

3. When the berm is positioned correctly, it is secured by looping Contractor
galvanized steel wire over each pair of posts surrounding the berm
(bank side to river side). Additional steel staples are also used to
secure the wire to the posts.
4. The loops of wire are then strained so that they are held tightly
over the berm.
5. Each row of chestnut posts is hammered down with a fencing
maul, permanently securing all material positioned in the berm
under the loops of strained wire they are attached to.
6. Finally the berm is checked for material that may come loose and
cause blockages elsewhere in the river channel. Excess wood stick-
ing out from the berm is also trimmed to improve hydrodynamics.

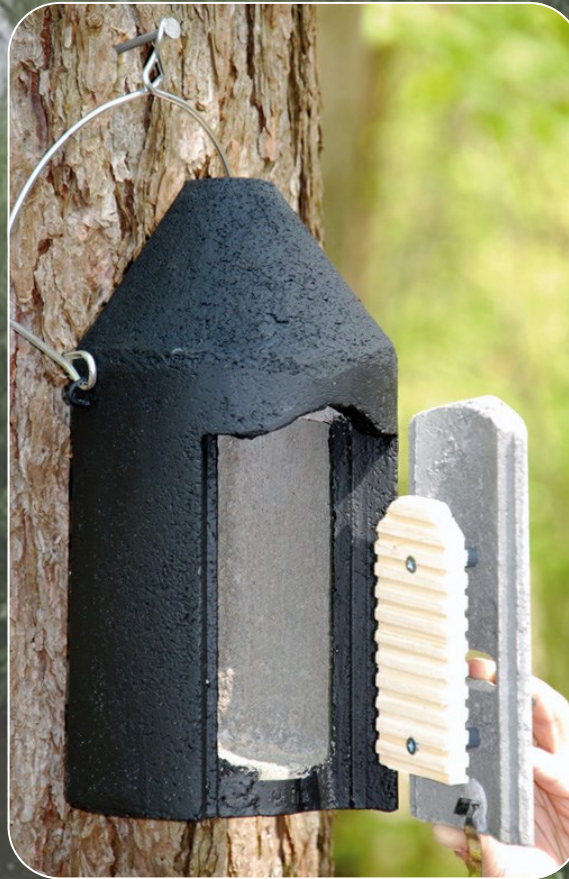
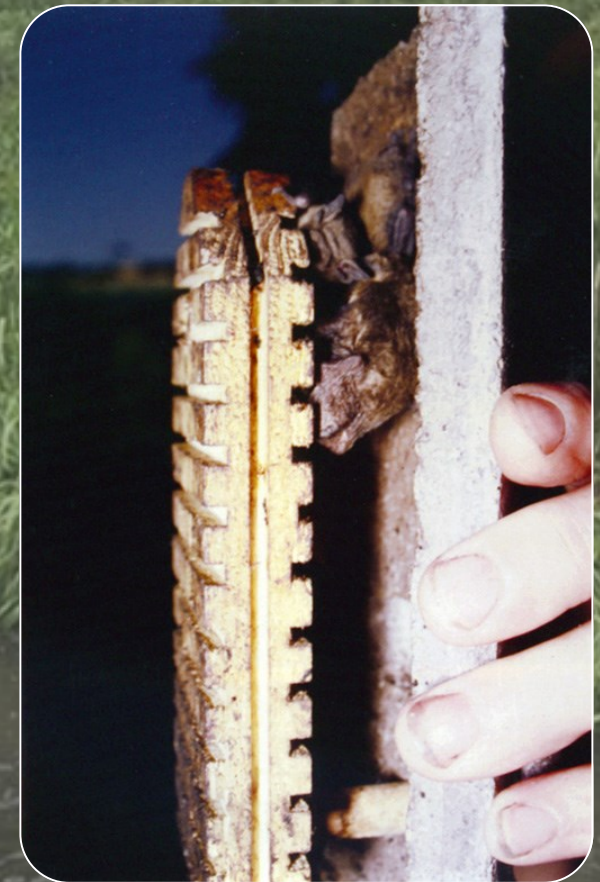
The box has a special double front panel, made of long-term resistant, grooved wooden boards, which creates a particularly popular and readily acceptable roost for crevice-inhabiting Bats, for example Nathusius' Pipistrelle, Daubenton's and Pipistrelle Bats.

The Bat Box can be easily converted into a 2F Bat Box without double front panel or a 2M Nest Box for Birds at any time. The front panel can be removed for inspection and cleaning.

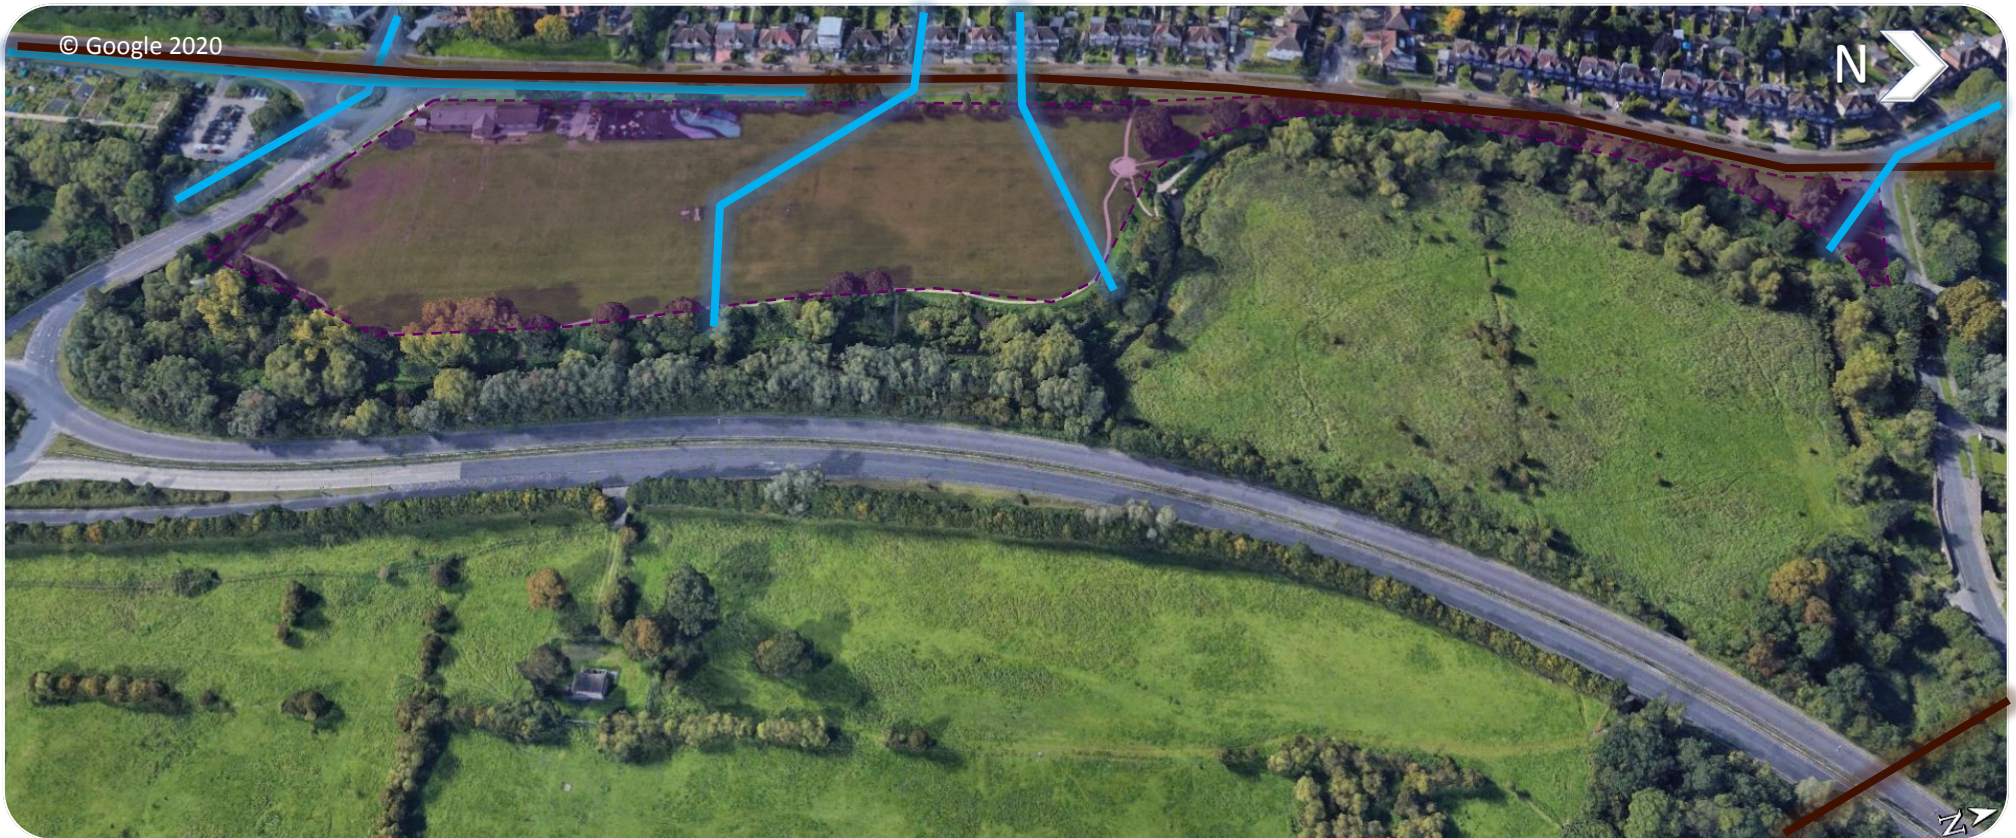
Utilities Search

Sewers - Foul

Sewers - Surface

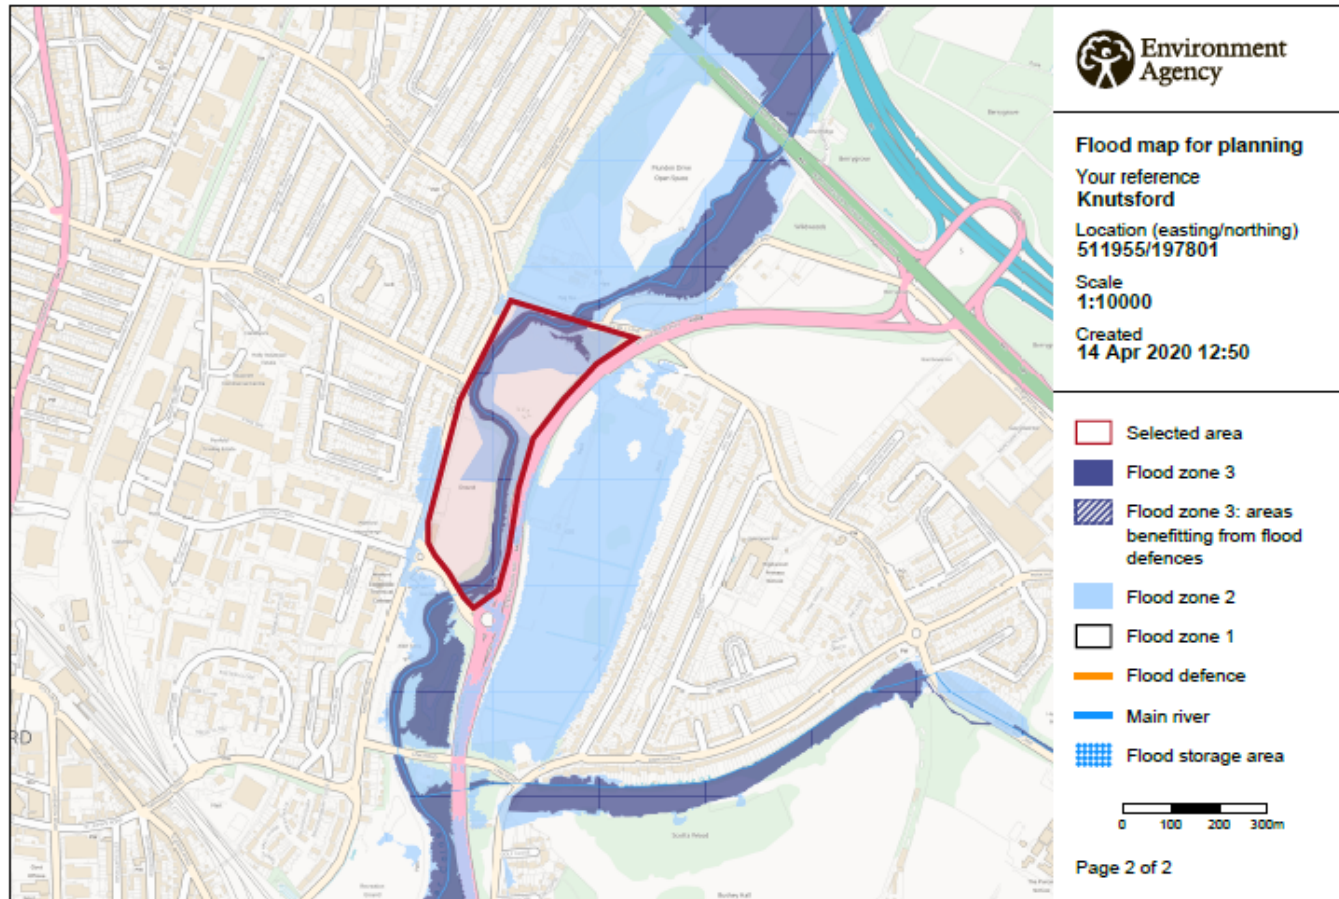
Flood Map

The majority of the Western floodplain is in flood zone 1 due to its high topography. Parts of this area, including the land around the constructed wetland, could be used to relocate materials arising from construction works elsewhere on site. Any proposals of this nature will have to be agreed with Watford Borough Council.

The majority of the Eastern floodplain is in flood zone 3. The backwater and Hillfield Brook restoration works proposed in this area should help to increase floodwater storage capacity. Materials arising from construction must be redistributed elsewhere or sent to landfill.

Any works proposed within the main river channel should not encourage out of channel flow and should not cause any significant obstruction or impoundment.
