Waterfields Recreation Ground

River Improvement Plan

**WATFORD
BOROUGH
COUNCIL**

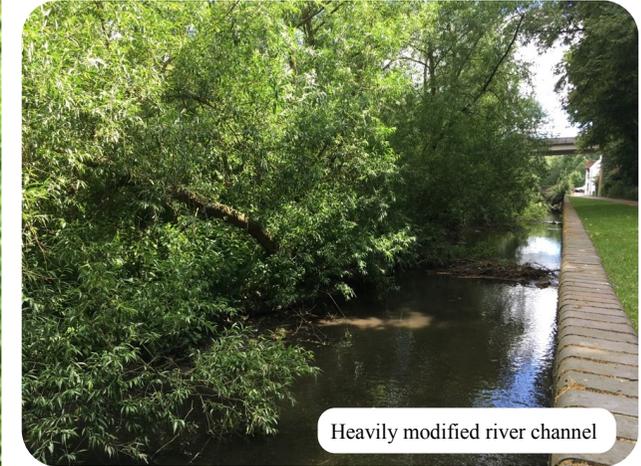
River Profile and Course

The river does not follow its original course through the site and was extensively modified in the mid 19th century to create a feature known as *The Watford Cut*. The Cut was a brick banked leat that diverted away from the original course of the river in the location where the five arches viaduct now stands. The feature flowed south through Watford, providing power to important industrial sites, such as Watford Mill. The cut eventually re-joined the main River Colne in what is now Oxhey Park. The majority of the Watford Cut was filled in during the 1980s following the decommissioning of its watermills and other industrial sites in the early 20th century. The only section of the feature that remains today, is what is now the main River Colne running through Waterfields Recreation Ground.

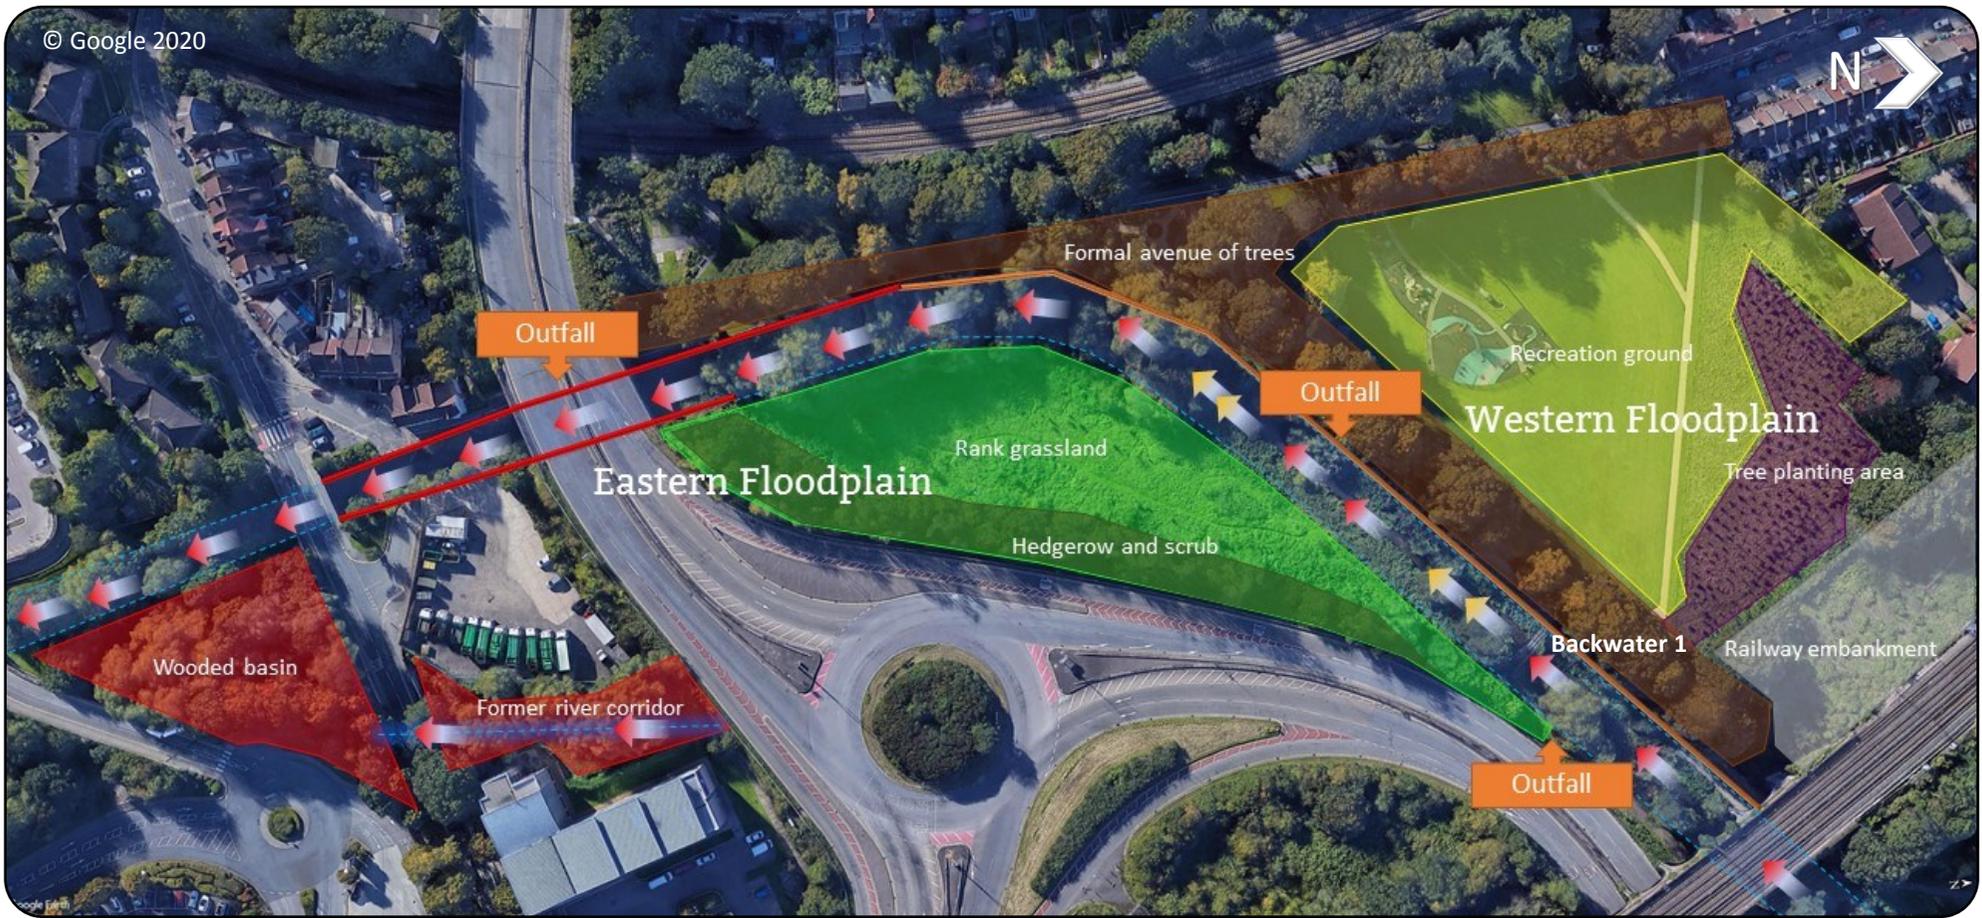
Waterfields Recreation Ground habitat map

- 1** Floodplain woodland
- 2** Rank grassland
- 3** Hedgerow & scrub
- 4** Formal trees
- 5** Amenity grassland
- 6** Tree planting area
- Flowing water
- Sheet piling
- Brick/concrete

Three outfalls are present along the river channel and have been observed to regularly pollute the watercourse (CVFC Pollution Monitoring Application, 2019). The locations of the outfalls are illustrated on page 4. The worst offending outfall is located directly beneath the Beechen Grove road bridge. Site users regularly complain about the foul smell and visual signs of pollution as they enter the recreation ground from upstream.

There are three outfalls present at Waterfields (see habitat map on page 4 for location), the outfalls have been observed to pollute the river on a regular basis (CVFC, 2019) and will contribute to the progressive decline in ARMI scores as the river flows through Watford. The outfall that most frequently pollutes the river is located beneath the Beechen Grove Road Bridge. Regular checks have shown that the outfall shows signs of pollution on most days and there is often a strong smell of sewerage beneath the road bridge.

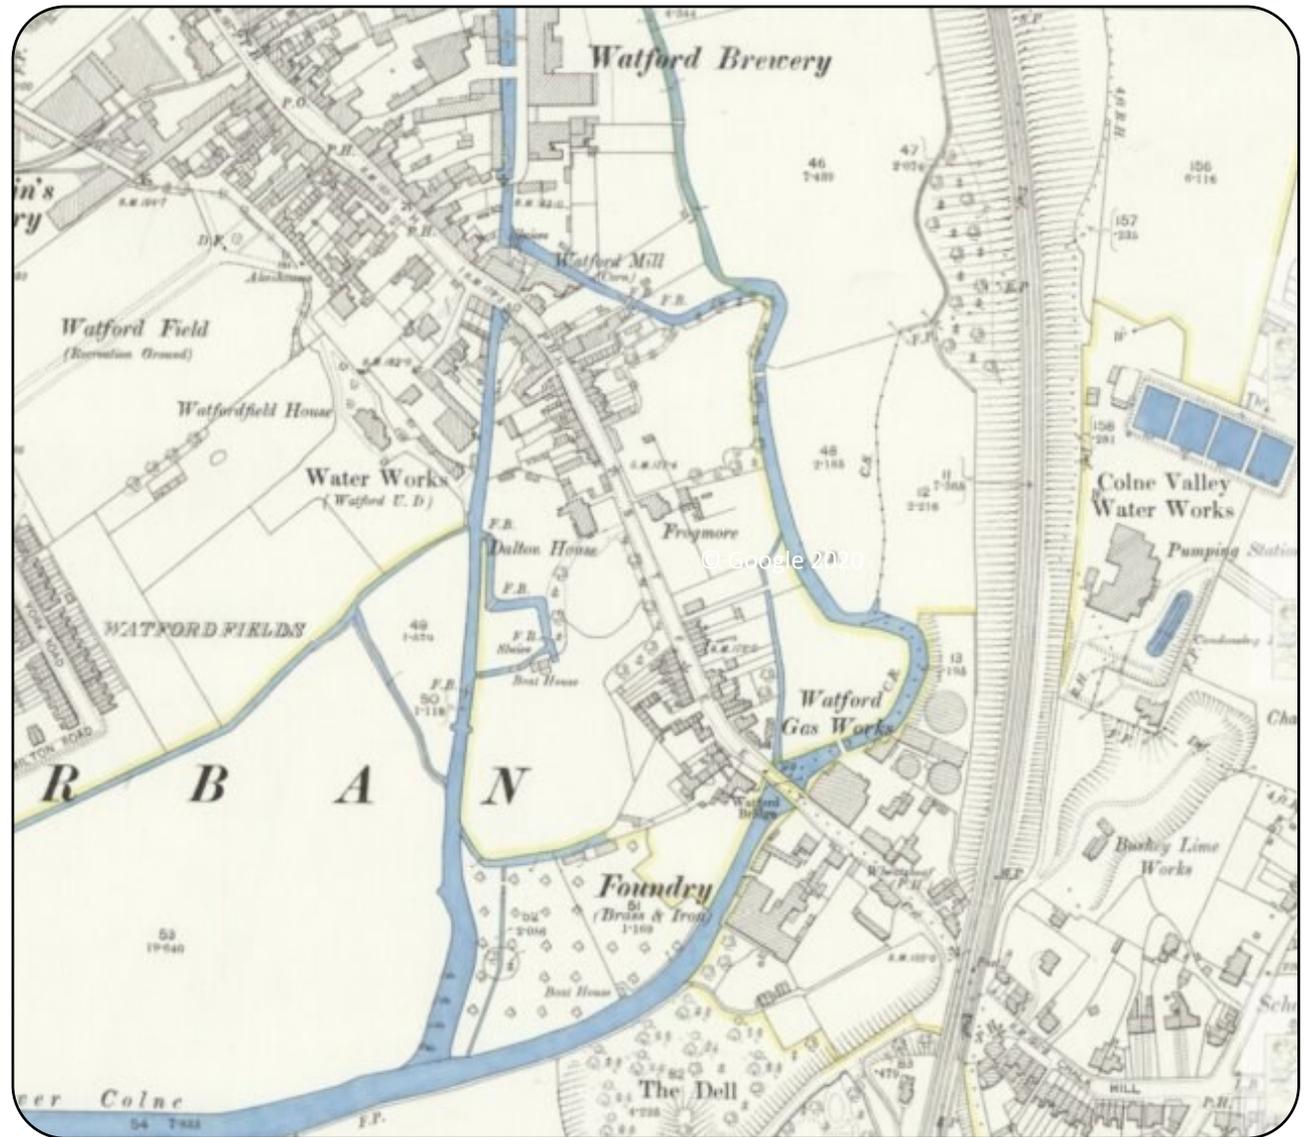
Ordnance Survey 25-inch map. Hertfordshire Sheet XLIV.6 1896 (detail). Showing the location of the Watford Cut and main river Colne.

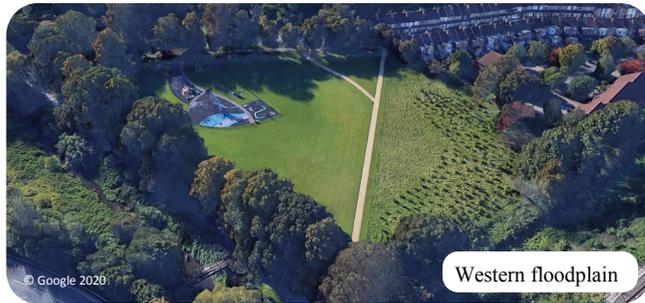
Western Floodplain

The Western floodplain is comprised of historic landfill resulting in the topography of the site being significantly raised in relation to the river corridor. As a result of this, the river is not able to laterally expand onto the majority of the floodplain during times of high flow. This has resulted in an elevated floodplain that is dry in nature, with no wetland features.

The floodplain is managed for sport and recreation purposes and therefore does not present many opportunities for habitat improvement. An avenue of mature Common Lime borders the formal path along the river, but the river is sparsely vegetated in comparison with other parks to the north of Watford, reflecting its more formal nature.

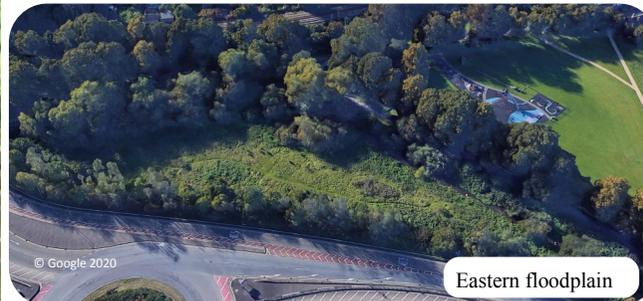
Eastern Floodplain

The Eastern floodplain is not comprised of landfill but still appears elevated due to the incised nature of the river channel. The area offers informal open space comprised of rank grassland, nettle, bramble and other ruderals, pockets of developing scrub and a wooded fringe along the border of the Stephenson's way. The compartment provides seclusion and refuge for wildlife which contrasts the formal nature of the Western Floodplain.

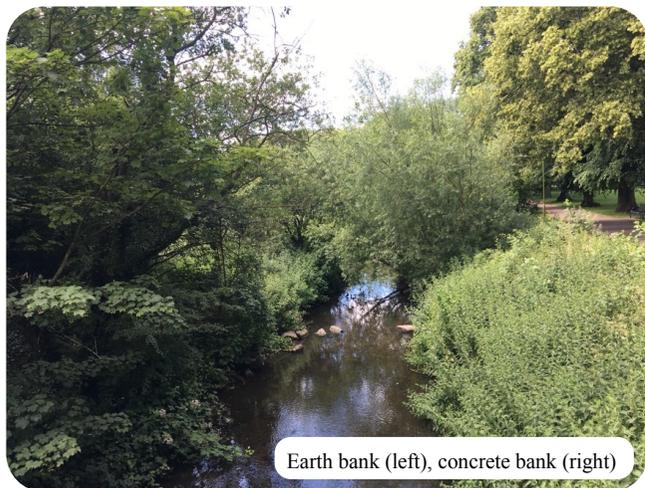
The western bank of the river is comprised of earth throughout the north of the site and is clad with metal sheet piling throughout the southern section. The earth bank face offers the best diversity of species on site but is still extremely limited in comparison to other sections of river in the area. The bank is predominantly characterised by Crack Willow with a Stinging Nettle understorey. Invasive non-native, Himalayan Balsam is also present and is likely to thrive due to the lack of competition with other native plant species. Similarly to the eastern bank,

the area of sheet piling to the south of the site offers little botanical interest. River banks such as these offer little habitat for native wildlife, such as water voles, kingfishers and fish. Water voles prefer gently sloping earth banks with abundant emergent vegetation, kingfishers prefer secluded earth bank faces with nearby tree cover and fish prefer complex littoral habitats with abundant cover from predators. Intervention is required to re-naturalise the river's banks to provide the correct conditions for a diverse range of wildlife to thrive and to ensure habitat connectivity to sites upstream and downstream.

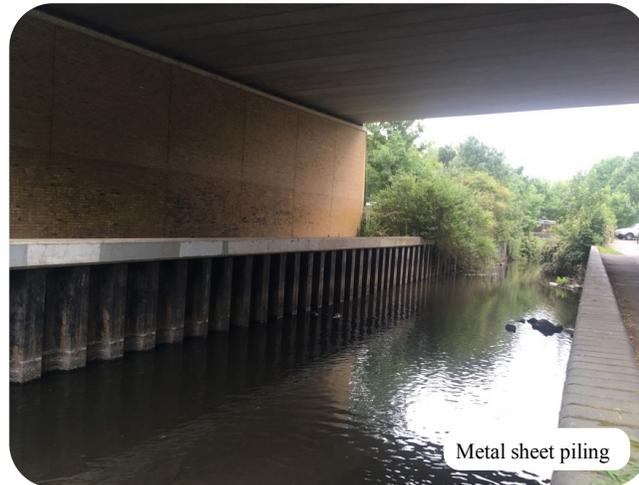
Efforts have recently been made to adapt the metal sheet piling to the south of the site to provide Kingfisher nesting habitat. This was achieved by creating a hole in the sheet piling and installing a kingfisher nesting box. The box will be monitored in years to come to assess how often it is occupied. If successful, this enhancement will be replicated elsewhere on site.

The land to the south of Beechen Grove is used as a recycling depot for Hertfordshire County Council. Although the site does not offer opportunities for habitat improvement, a kingfisher nesting box has recently been installed in the area of metal sheet piling bordering the river by Groundwork and Community Connections Projects CIC. The nest box should be monitored each season to see if it is occupied. The occupancy rate should also be compared to other sites where nest boxes have been installed in the catchment to deduce which site parameters lead to the highest occupancy rates.

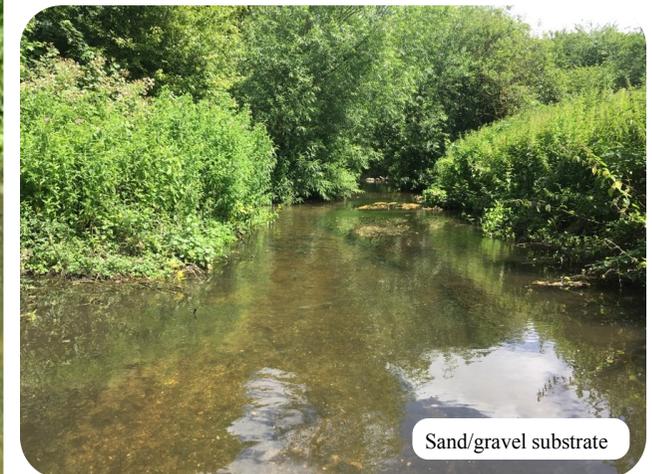
Throughout the majority of the site, the river is a low energy watercourse with a uniformly smooth flow type. The river is most shallow (0.3m) and fast flowing towards the north of the site, with occasional areas of rippled flow, but becomes increasingly deeper (<0.5m) and slow flowing as it progresses southwards. The river's substrate also reflects this change, with sand and occasional gravels predominantly found to the north of the site and with silt substrate and organic debris dominating the southern section.

The dominance of fine substrate reflects that the river has a poor ability to appropriately sort and grade sediment into morphological features and that the river is still recovering from the impacts of modification. Areas such as these do not provide favourable conditions for diverse fish and invertebrate populations to thrive, which require clean well

oxygenated gravels. Intervention is required to catalyse morphological processes and to provide a self-sustaining, dynamic water course.

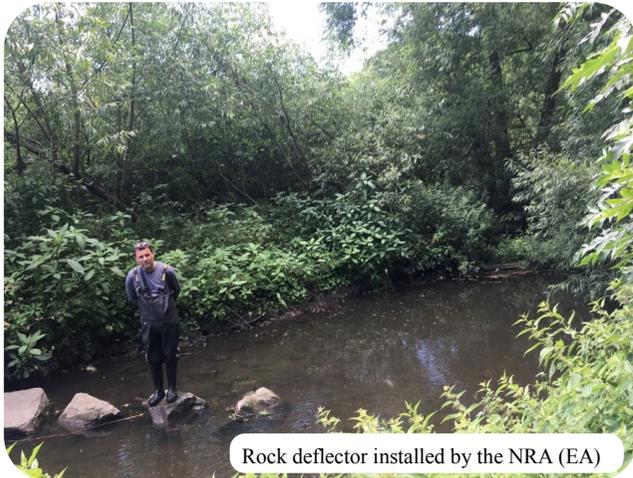
Rock deflector installed by the NRA (EA)

Occasional areas of good flow and substrate are intermittently dispersed throughout the length watercourse, with many of these areas being the product of the river restoration project undertaken by the NRA in 1996. Most areas such as these provide artificially created riffle habitat and contain rock deflectors and imported substrate (gravel flint reject stone). Some features function better than others in respect to their ability to increase flow and to provide self-cleaning gravels. Some deflectors have done very little to increase scour and flow, but have worked to narrow the width of the watercourse and have increased in-stream habitat complexity.

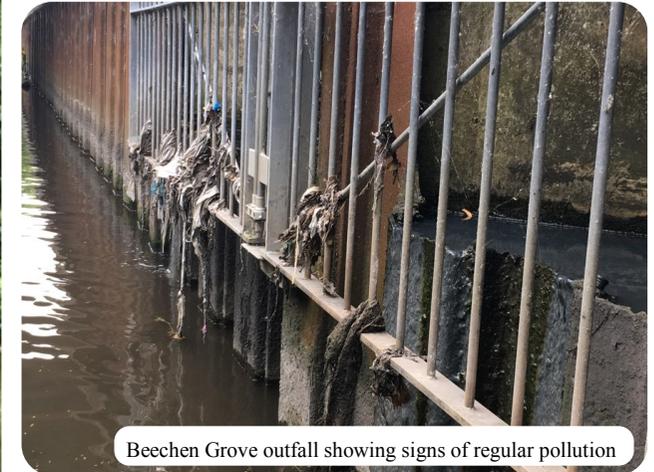
Beechen Grove outfall showing signs of regular pollution

The pollution can be attributed to domestic sewerage misconnections and links between the foul and surface water sewerage system. Thames Water have identified that the outfall is served by a catchment area of over 2,500 properties and have committed to conducting tracing exercises to locate the sources of pollution. Until the sources are identified and rectified, the river will continue to receive persistent

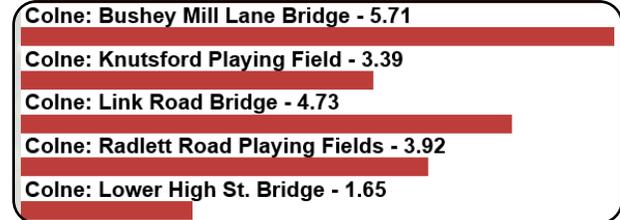
ARMI results for all sites (upstream to downstream)

The two monitoring sites upstream and downstream of Waterfields return some of the poorest ARMI results in the Colne Catchment. Radlett Road (0.3km upstream) scores an average of 3.64 and the Lower

Highstreet Bridge (1km downstream) scores an average of 1.67. This illustrates there is a significant decline in water quality from upstream of the site to downstream of the site which is reflective an overall trend of declining water quality throughout Watford.

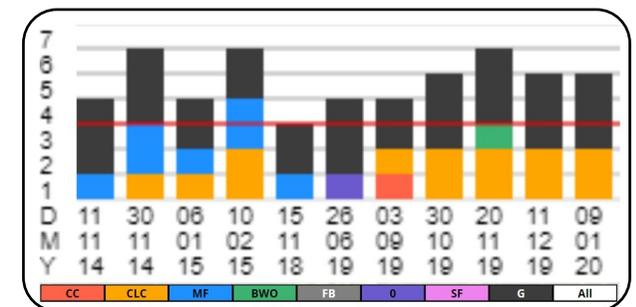
ARMI results for closest site downstream (LHSB)

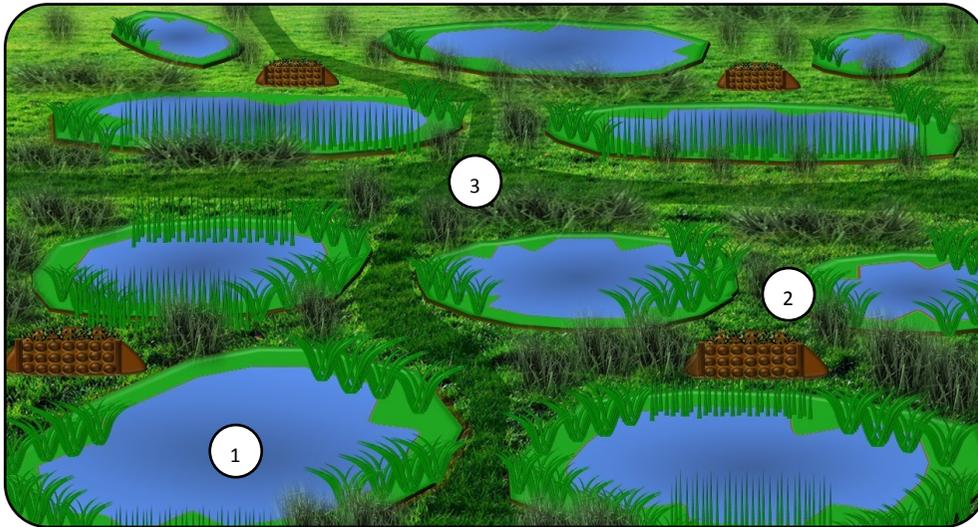
Pondscape

1. Ponds should be created in close proximity to one another and should be of varying depths, shapes and sizes. This will promote connectivity between each pond and will provide niches for differing species to occupy.
2. Amphibian hibernacula should be created in close proximity to each pond. This is achieved by digging a shallow trench, piling brushwood within the trench lengthways and then covering the structure over with soil. This will provide an insulated refuge for amphibians to seek shelter during winter months.
3. The peripheries of each pond should be sewn with Emorsgate EP2 to help the wetland establish. Paths should be mown to provide access to key areas so the pondscape can be maintained and appreciated by site users.

The ponds water depth should vary between 0.3-1 meter. They can be dug by hand or with the assistance of a mini digger.

The pondscape should be located adjacent to the area of scalloped river bank in order to promote connectivity to the river corridor.

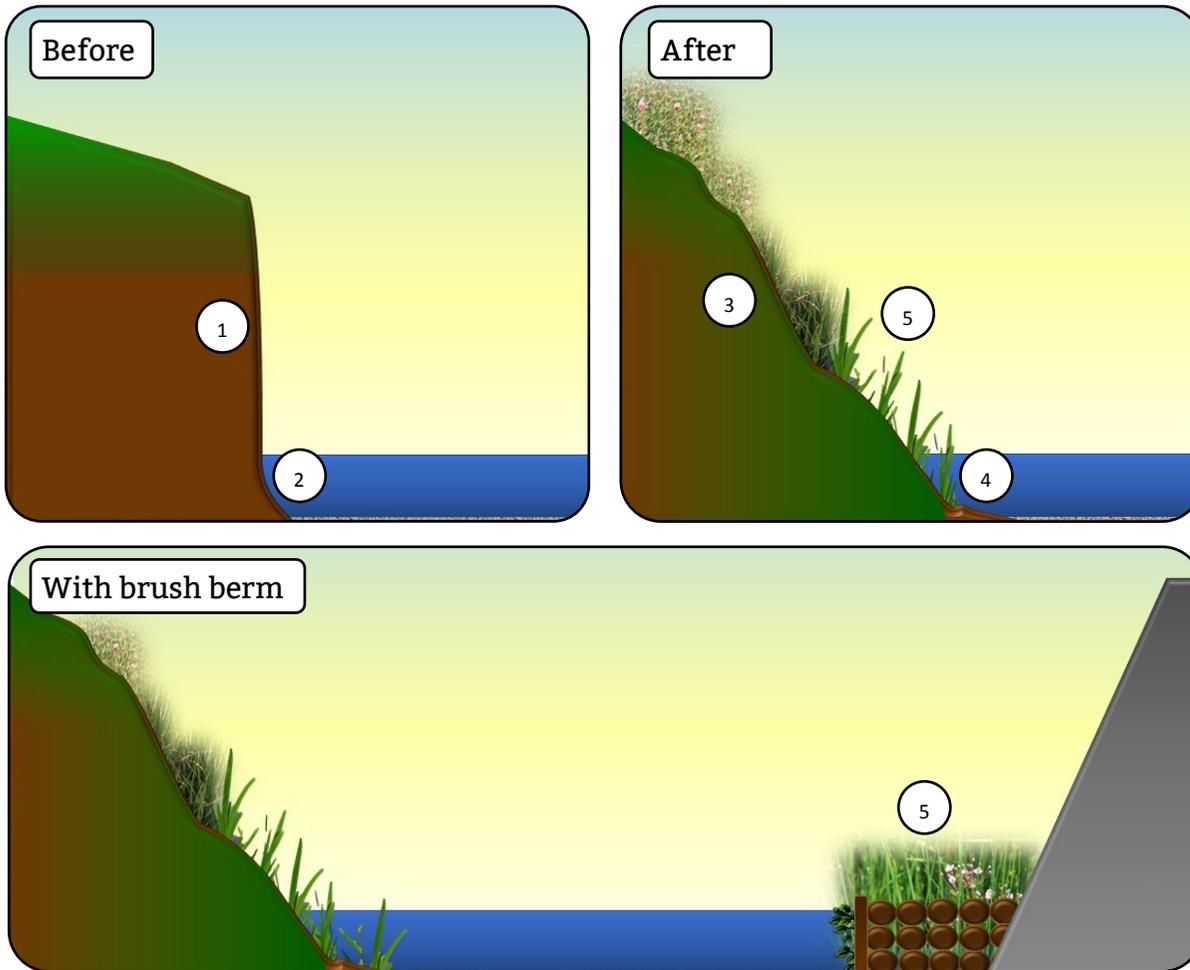
Bank Scalloping

1. Steep and bare river banks are susceptible to erosion and do not support diverse arrays of riparian and littoral plant life. They are also unsuitable for key species, such as water voles.

2. The river channel is of a uniform depth and flow, meaning that there are few, sheltered, shallow areas in the margins of the river where aquatic plants can colonise.

3. Steep banks can be scalloped using a long reach excavator in order to provide a more shallow gradient. This provides the right conditions for plants to establish and promotes improved connectivity for wildlife between the river channel and flood plain.

5. Brush berms should be installed on the opposite bank to each scalloped area. This will provide a natural edge to the western concrete bank, ensuring that plant life is present in both margins of the river. The effect of pulling back one bank away from the channel and extending the other into the channel should also help mimic natural sinuosity and will provide a central channel which is better suited to low flow conditions.

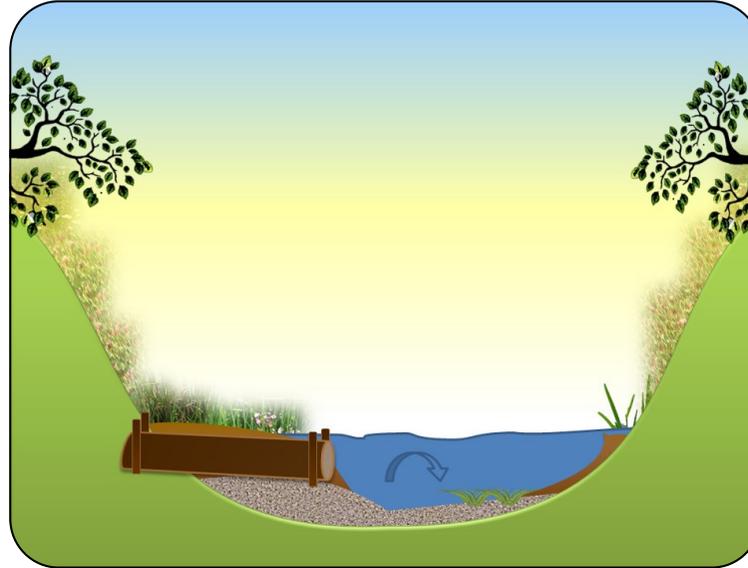
Flow deflectors are used to pinch the width of the river which reduces siltation, creates scour and facilitates a variety of different flow types.

They are created by securing tree trunks to the bed of the river with chestnut posts and galvanised steel wire. A pool feature can also be created downstream of each deflector's location to provide a variety of depths. Materials won from excavating pools can be repurposed to create riffles or side bars, which further increase physical habitat complexity.

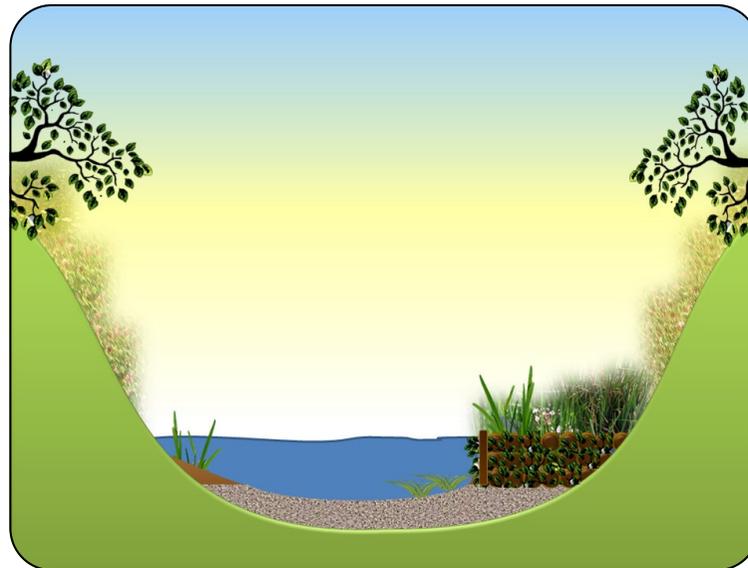
Brush berms can also be installed to pinch the width of the river and can be used to mimic natural sinuosity. They provide useful low lying areas for aquatic plants to colonise in addition to providing physical structures for aquatic wildlife to shelter.

They are created by using tree branches to reshape the river, which are secured in place with chestnut posts and beams or galvanised steel wire.

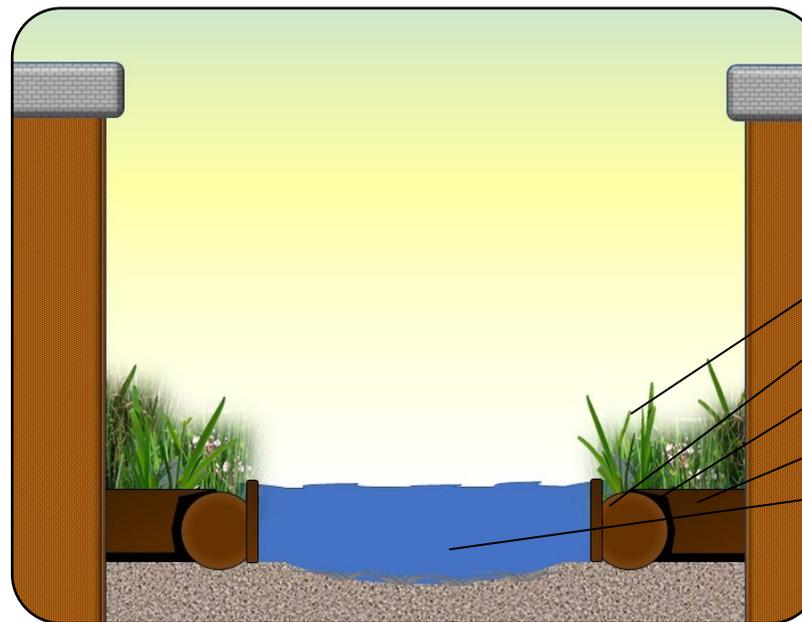
Aquatic Shelves / Low Flow Channel

1. Sheet piling provides little cover for wildlife and is not readily colonised by aquatic plant species.
2. There is little variation in depth due to the modified nature of the river channel. It is too wide.
3. Due to the rivers enlarged profile, it is a low energy watercourse with little variation in flow. Morphological processes do not freely occur and the river bed is covered in layer of silt.
4. The enlarged channel is not well suited to low flow conditions and is susceptible to the effects of climate change.

The provision of a low flow channel will ensure that the river continues to offer good habitat and geomorphology during times of low flow. Faster flowing water in the centre of the channel will prevent siltation from occurring and promote the growth of beneficial submerged plant species.

The banks of the low flow channel should be low in profile, and sit just above the normal water level of the river. This will enable the wider channel to be utilised for water storage during high flow events.

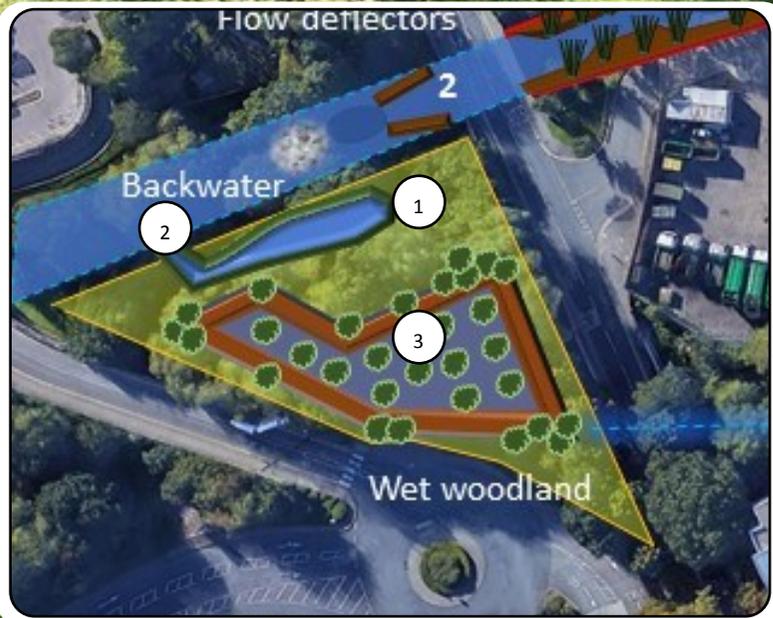
Backwater and Wet Woodland

1. The backwater should be created within the area of sloped bank adjacent to the river and should run parallel to the channel with a downstream connection point. Its banks should gently slope to form marginal planting shelves. Plug plants should be introduced after completion.

2. The bed level of the backwater should be identical to that of the main river channel to provide a constant connection between the two features, allowing for the ingress/egress of wildlife.

5. Select native species should be used to provide both an understory (Grey willow, Elder, Osier, Hawthorn, Goat Willow, Holly, Hazel, Blackthorn, Guelder Rose) and canopy (Alder, Crack Willow, Oak, Black Poplar, Ash, White Willow) to the woodland. Trees should be planted with 5 meter spacings, with occasional clumps of identical species.

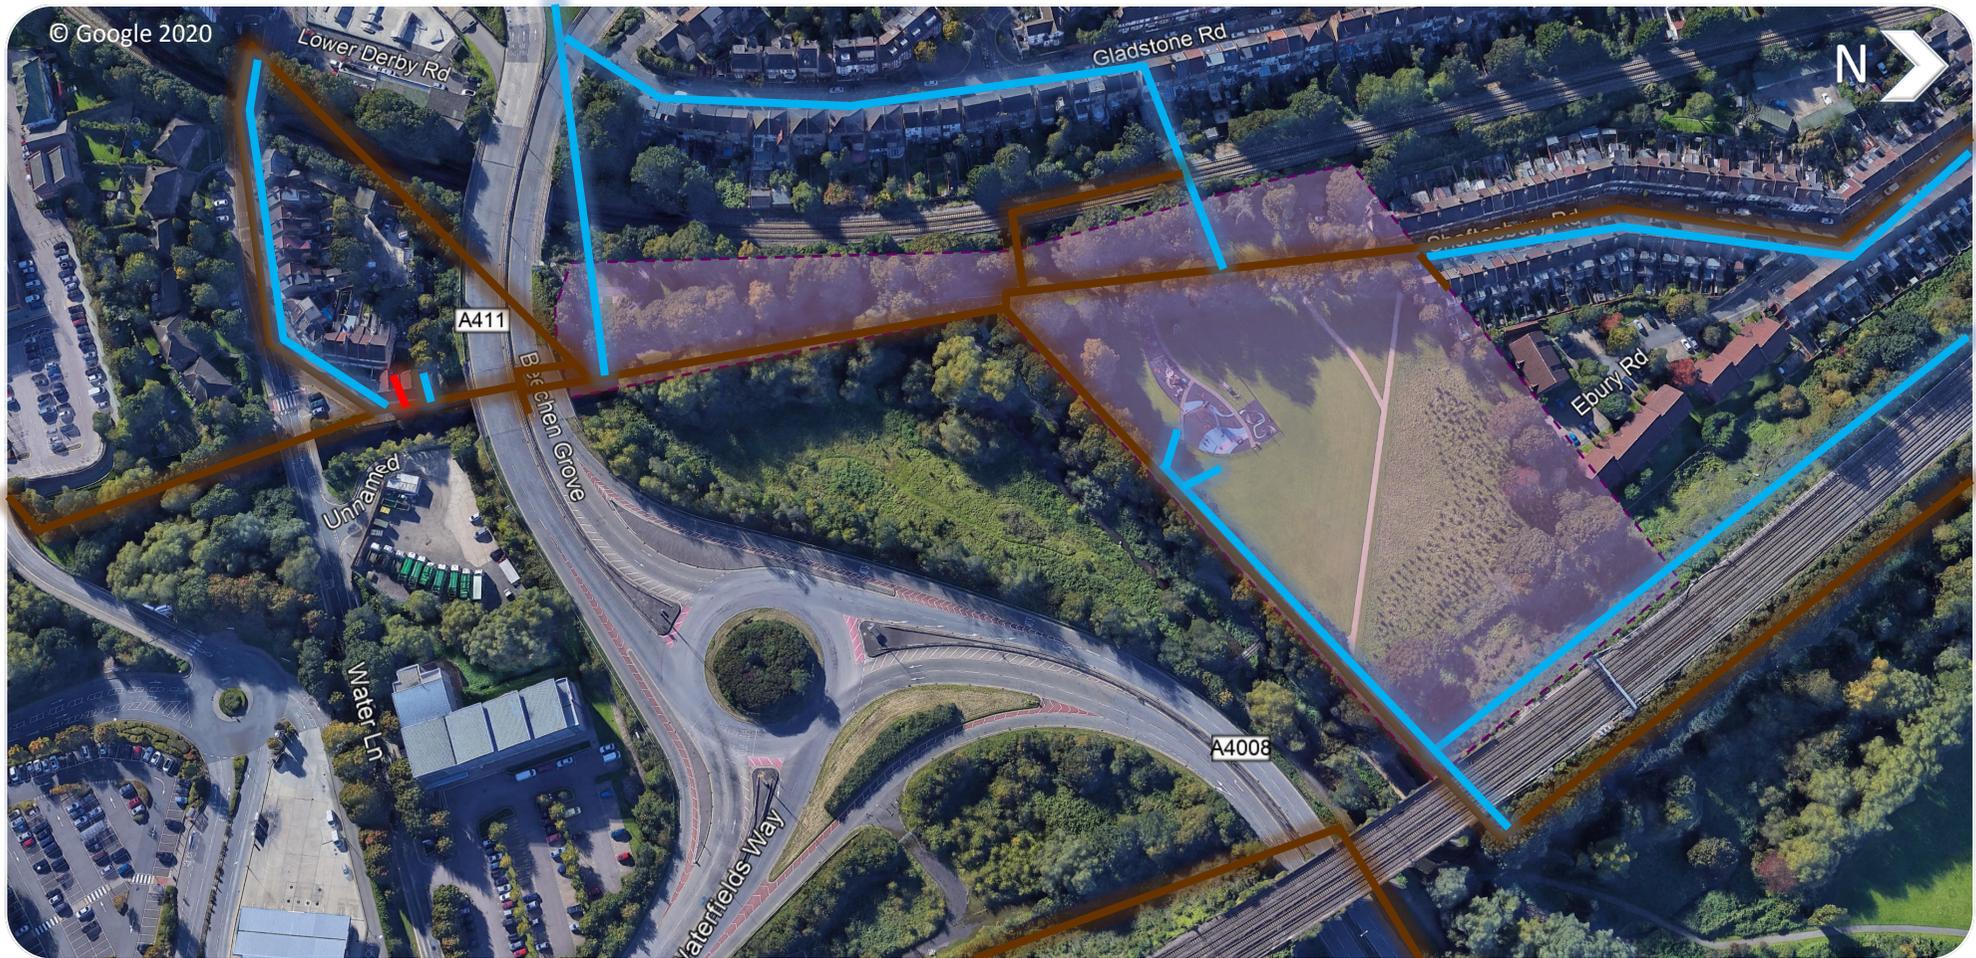
Utilities Search

Sewers—Surface

Sewers—Foul

The locations of utilities should be interpreted as an initial guide in order to inform further design work. It is recommended that a new utilities search is conducted by the appointed contractor before construction works commence

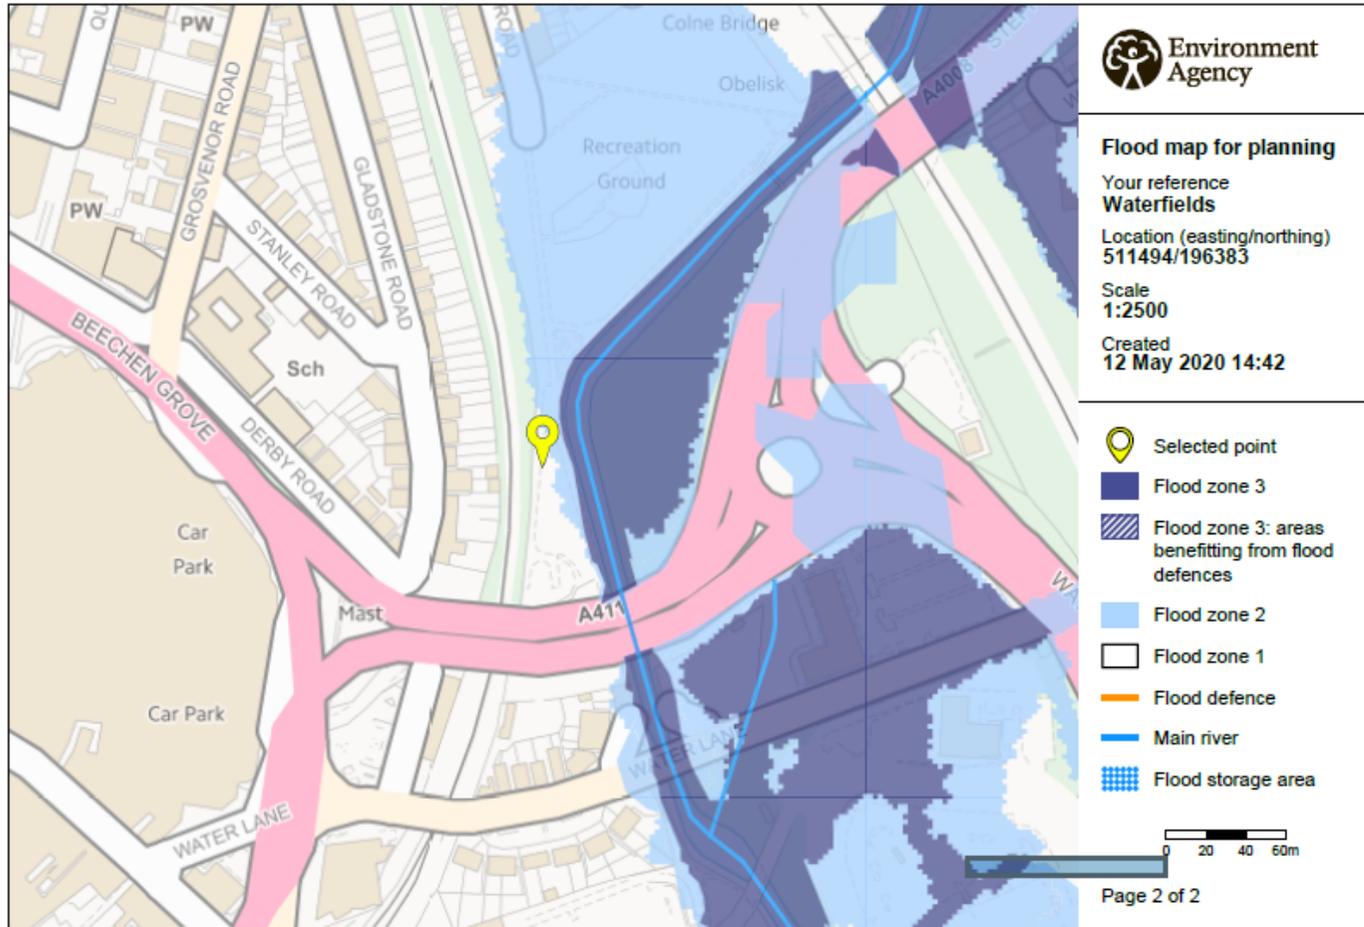
Flood Map

The majority of the Western floodplain is in flood zone 1 due to its high topography. Parts of this area, including the land around the constructed wetland, could be used to relocate materials arising from construction works elsewhere on site. Any proposals of this nature will have to be agreed with Watford Borough Council.

Any works proposed within the main river channel should not encourage out of channel flow and should not cause any significant obstruction or impoundment.
