Riverside Recreation Ground

River Improvement Plan

**WATFORD
BOROUGH
COUNCIL**

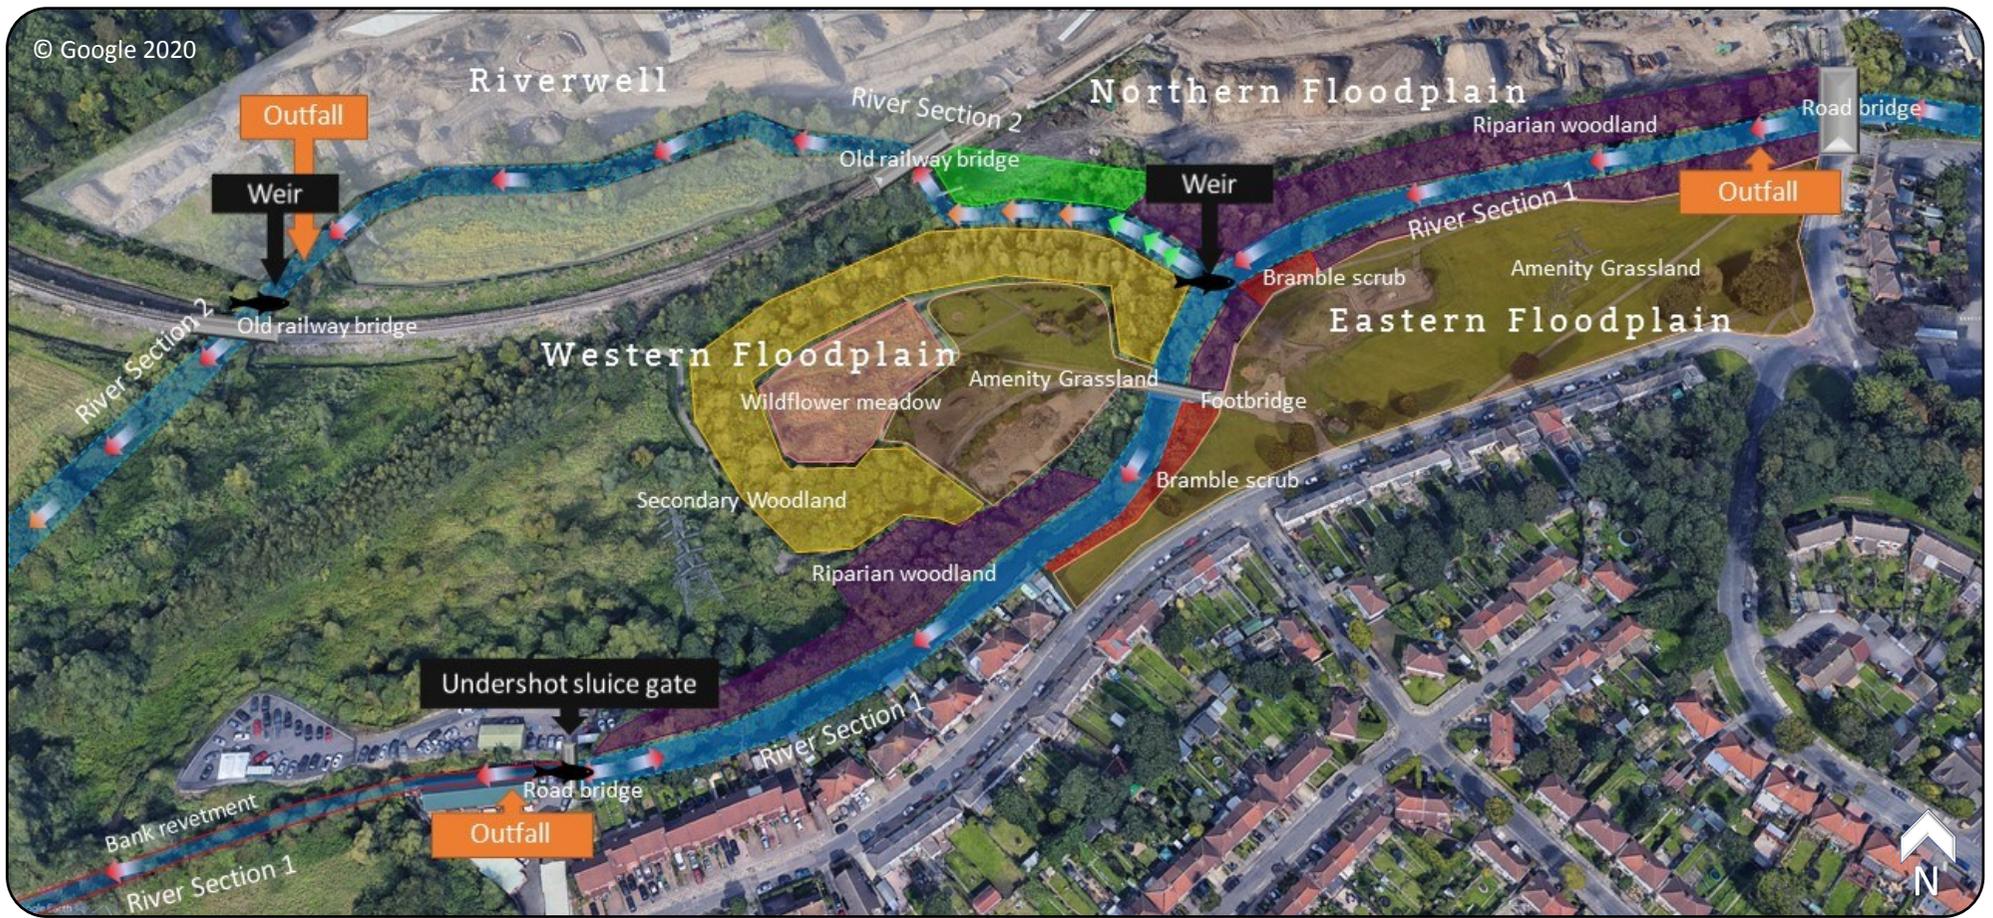
As section 1 progresses further towards the sluice gate it becomes increasingly deep and slow flowing, with thick layers of silt accumulating upstream of the structure. This channel is choked with emergent vegetation and has a very undefined profile. The sluice gate retains a significant head of water and is currently not operational. This has resulted in the loss in ability to control flows downstream of the structure and comparatively high water levels upstream of the structure. A relatively small amount of flow is able to pass through the undershot sluice and as a result of this the channel downstream is drying out, with very low water levels and abundant vegetation growing across the full width of the riverbed. The section of the channel immediately below the sluice has brick banks and is exposed to a high degree of human pressure due to the presence of residential properties and a mechanics yard in the riparian zone. As the channel progresses towards

emerging at the Watford Riverwell site. The river has a noticeably incised profile at the Riverwell site and it appears that the river has recently been unsympathetically reprofiled. The banks of the river are especially steep, with little vegetation present, meaning that they will be exposed to erosion during high flow events. The bed of the river also appears as if it has been significantly lowered. Remnants of the former gravel bed are visible in the margins of the river, which shelf steeply to a silty riverbed. A second weir is present at the most downstream extent of the site, which causes an impoundment and retains a head of slow flowing water upstream.

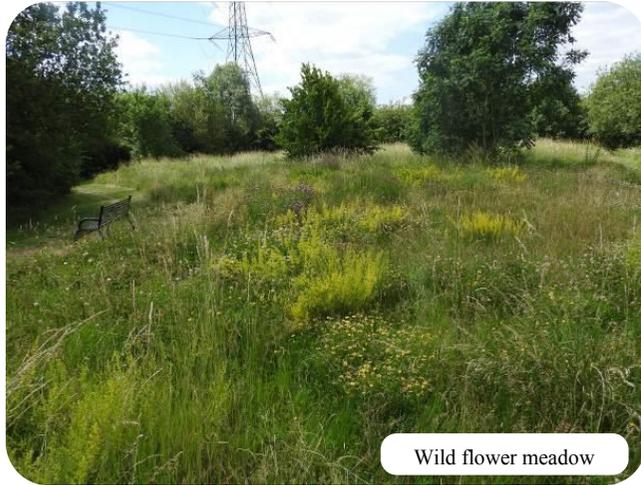
Wild flower meadow

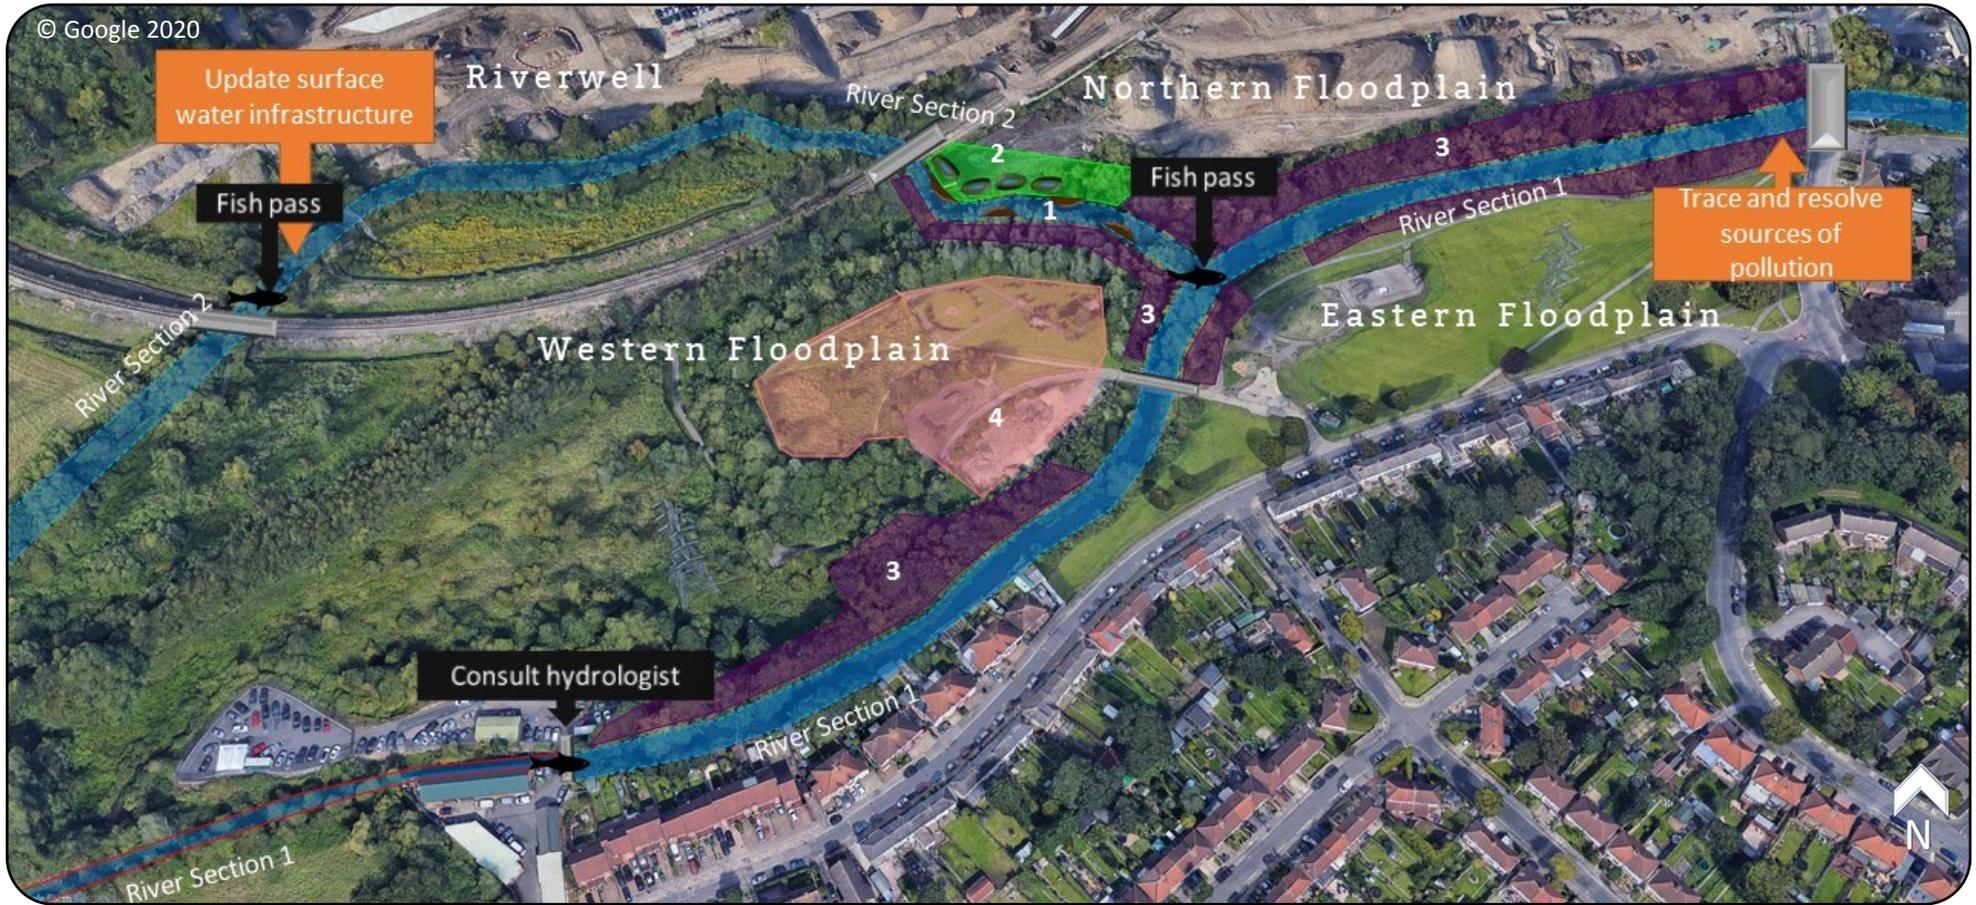
1. There is little variation in the depth across the channels cross sectional and longitudinal profile.
2. There is little variation in flow type, with the flow of the river being predominantly smooth and slow flowing.
3. The river channel is not suited to low flow conditions and is susceptible to the effects of climate change.
4. A number of historic control structures alter the rivers hydrology and pose as barriers to fish passage.
5. The river suffers from reoccurring pollution issues that limit aquatic biodiversity.

1. Riparian trees should be coppiced rotationally to maintain the current vegetative balance and levels of light and shade on site.

2. A mixture of brushwood berms should be installed in section 2 to stabilise loose sediment in the margins of the river. This will significantly improve the rivers crosssectional profile, providing a narrower and faster flowing central channel where morphological processes occur freely and sheltered areas in the margins of the river for aquatic plants to grow. If natural colonisation is slow, plant species from elsewhere onsite should be translocated.

6. The outdated surface water asset at the Riverwell site should be replaced with a solution that prevents regular pollution incidents from occurring.
7. If restoring flow to Section 1 is desired, a consultant should be engaged to model the

8. The surface water assets at the Riverwell site should be replaced with a solution that prevents regular pollution incidents from occurring.
9. Watford Water Quality Forum to instigate a pollution tracing exercise for the 'recreation ground outfall'.
